# **JASPER WILDFIRE:**

# **COMMUNITY IMPACT RESEARCH**

Project number: 301016432 Report number: WF TR 2025 N4

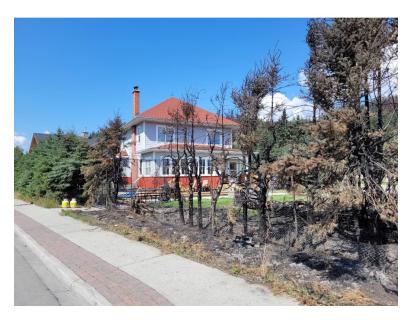
Figure 15: Dense spruce hedge surrounding a property.

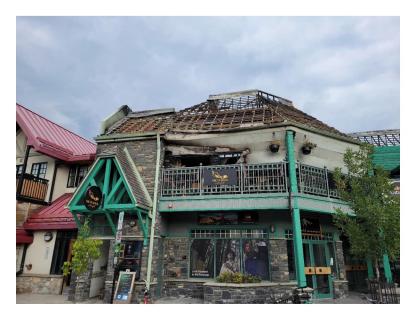
In the commercially zoned area north of Hazel Ave there were five ignitions that resulted in visible damage to the structures. All five of these ignitions were initiated by embers on the roof of the structures in the wood shake roofing material. One of the more destructive ignitions shown in Figure 19 resulted in the consumption of the entire upper portion of the roofing material and as the fire progressed, it started to burn down into the upper floor of the structure. Interestingly, the steeper section of the wood shake roofing material avoided ignition, potentially due to increased ability of the steep slope to shed any embers before they could smoulder into a sustained ignition.

Figure 19: Wood shake roofing ignited by embers in the commercial area of Jasper townsite.

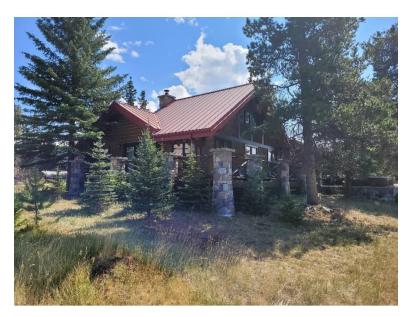
Figure 21: Dense seedlings and saplings around deck area of an unburned structure.

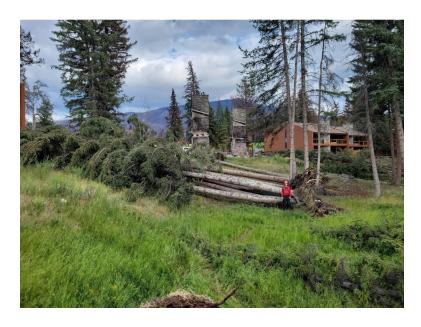
Figure 25: View looking east of the burned structure just northeast of Beauvert Lake at Jasper Park Lodge.

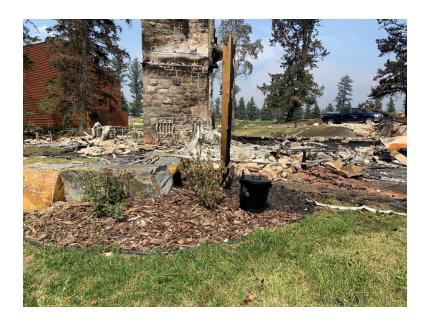
Figure 27: Vulnerability (mulch bed with fence attached to structure) present on the burned structure on the shore of Beauvert Lake.

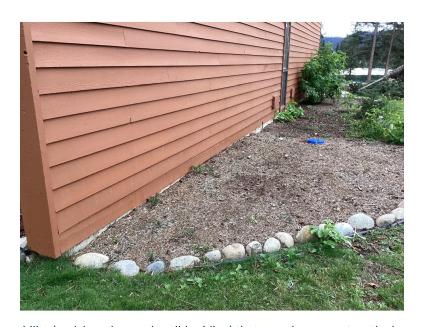
Figure 28: Vulnerability (mulch under combustible siding) that was also present on the burned structure on the shore of Beauvert Lake. Photo of identical adjacent unburned structure to show likely state before burning.

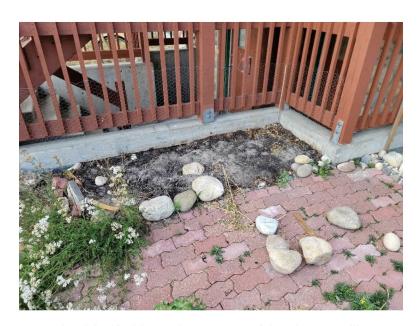
Figure 30: Extinguished ignition pathway on a surviving Thornton Village structure.

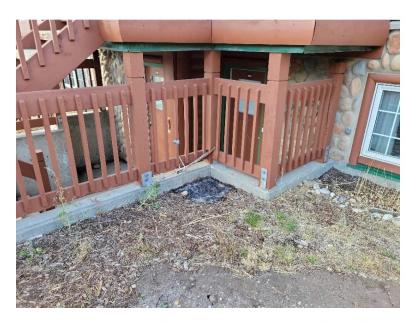
Figure 31: Ignited organic matter buildup around a surviving structure in Thornton Village.

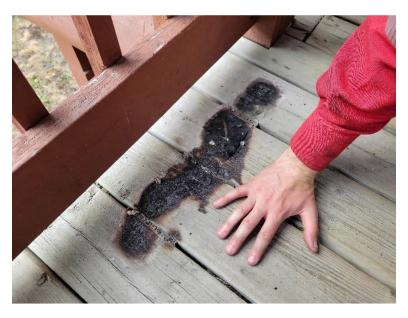
Figure 32: Burning of a surviving structures deck in Thornton Village. Ignition likely started from an ember in the tight crack between the ends of the deck boards where the most mass loss has taken place.

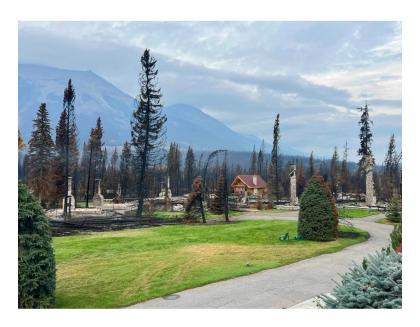
Figure 36: Surviving structure surrounded by burned structures:

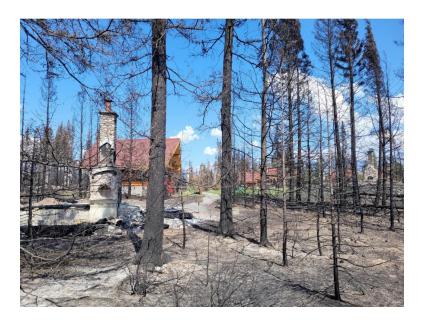
Figure 37: Burned pair to the unburned structure on the southwest side of the property.

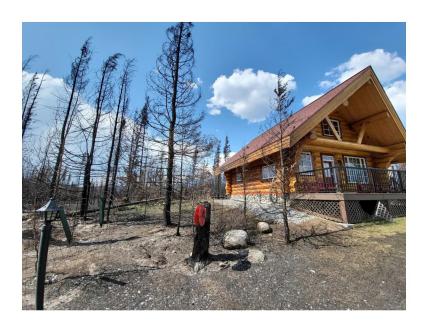
Figure 38: Close view of the side of the unburned structure showing the direction fire approached from.

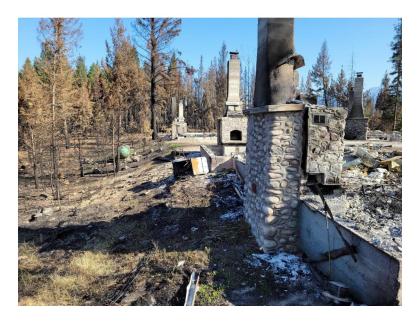
Figure 42: Continuity of wildland fuels on the west side of the burned structures in the northwest portion of Tekarra Lodge.

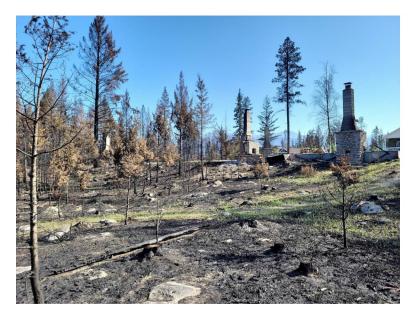
Figure 43: Larger scale view of the wildland fuels leading up to burned structures in Tekarra lodge.

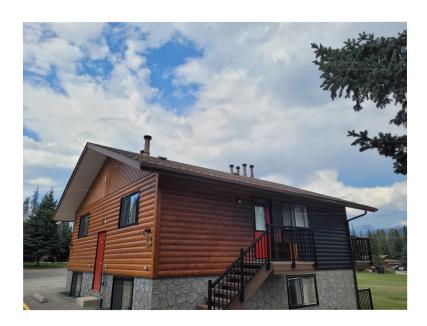
Figure 46: Structure with visible damage (yellow structure on the area map) adjacent to the burned structures.

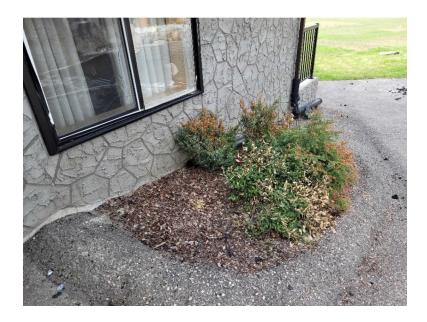
Figure 47: Mulch bed beneath window of structure with visible damage adjacent to the burned structures.

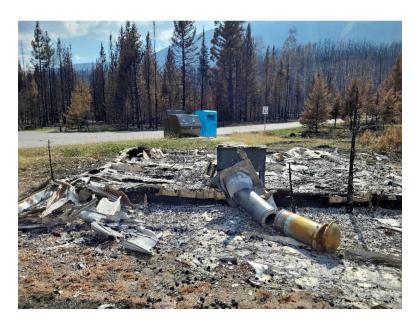
Figure 49: Burned cook shelter in Whistlers campground showing spruce seedlings and saplings growing up against structure.

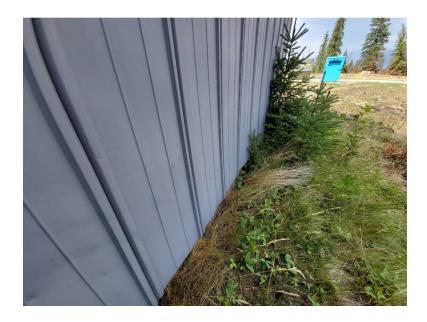
Figure 50: Unburned cook shelter in Whistlers campground with similar spruce fuels growing near its base.

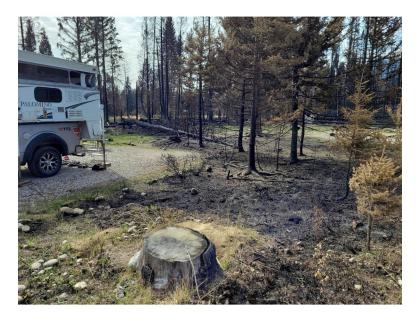
Figure 52: Surviving but damaged truck with hybrid hard and soft-sided camper with high intensity surface and intermittent crown fire leading up to and around it.

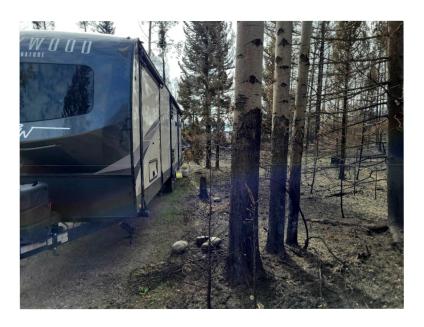
Figure 53: Hard sided trailer with moderate intensity surface fire surrounding it.

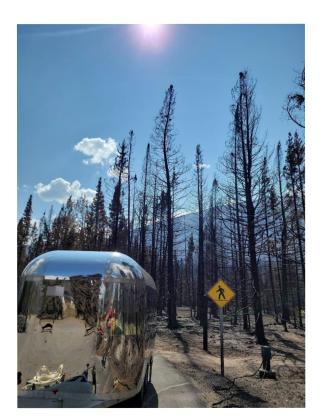
Figure 54: Minor damage to aluminum clad trailer that was surrounded by full canopy consumption crown fire in mature trees.

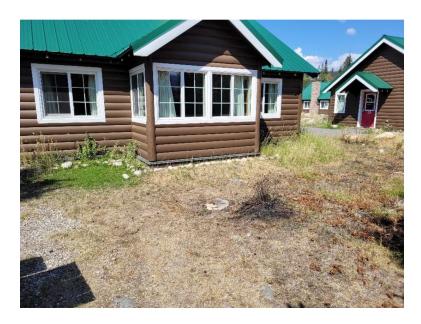
Figure 58: Fuel condition and load around the Pine Bungalows.

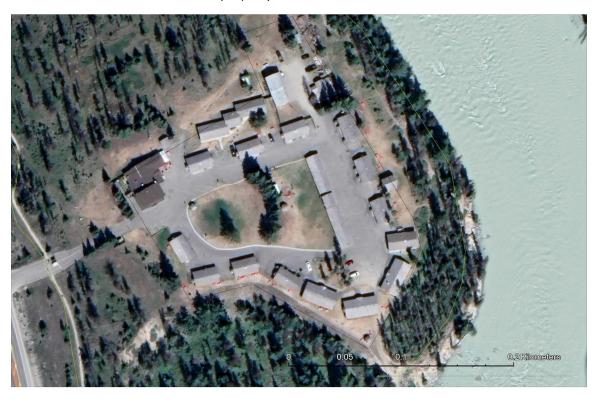
Figure 60: View of the Jasper House Bungalows property pre-fire. Only the maintenance structure on the top middle and main structure in the top left have asphalt shingles. The rest of the structures have wood shake roofs.
