ACTIVE ROCKSLIDES IN SWITZERLAND – UNDERSTANDING MECHANISMS AND PROCESSES

Erik Eberhardt, Engineering Geology, ETH Zurich, Switzerland
Heike Willenberg, Engineering Geology, ETH Zurich, Switzerland
Simon Loew, Engineering Geology, ETH Zurich, Switzerland
Hansruedi Maurer, Applied and Environmental Geophysics, ETH Zurich, Switzerland

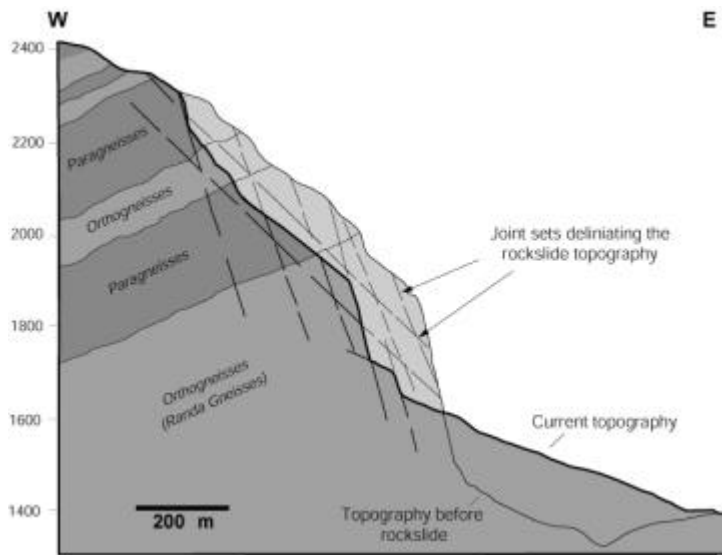
Figures 3 and 4 provide an illustration of this point using the 1991 Randa rockslide, which occurred in south central Switzerland. The failure occurred within a massive gneissic rock mass cut by extensive relief joints, parallel to the surface, cross-cut by faults (1, 2). The slide occurred in two stages with the first slide occurring on April 18, 1991 and the second failing on May 9, 1991. Although no clear triggering mechanism could be resolved from the seismic and precipitation records, it was noted that failure coincided with a period of heavy snowmelt (1). This can be seen in the snow height and temperature records for the Zermatt weather station (Fig. 4), located 10 km south of Randa. However, it can also be seen that this was not an exceptional event and that heavier snowmelts had been recorded in previous years. Again, a similar argument can then be made that if the slope did not fail during previous periods of heavy snow melt, why did it fail specifically on April 18, 1991?

Figure 3. Schematic cross-section showing the 1991 Randa rockslide (after (3)).

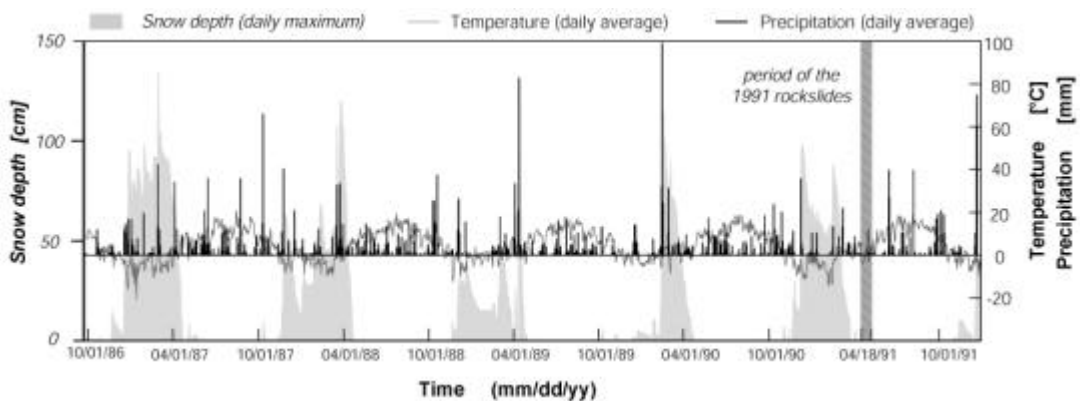
Figure 4. Snow depth, temperature and precipitation records for Zermatt climate station near the Randa rockslide (data provided by MeteoSchweiz).

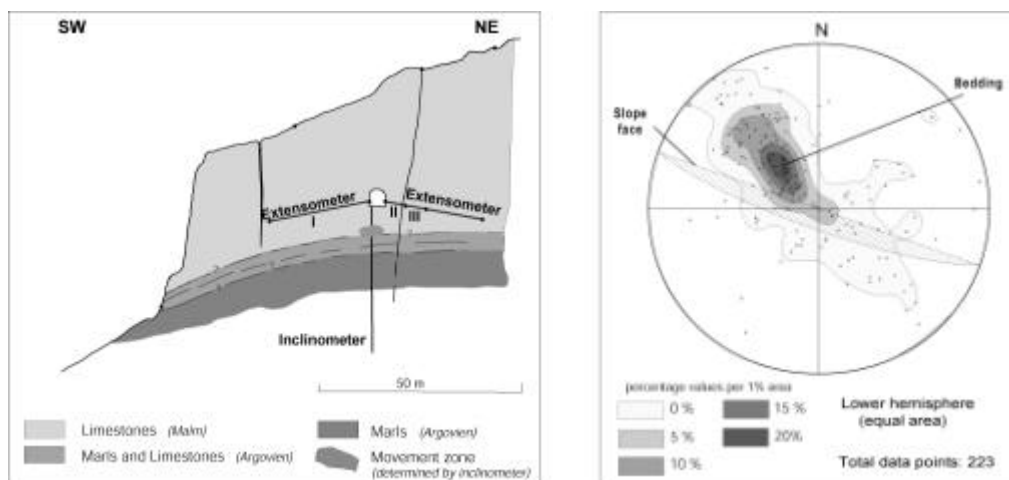
The unstable slope at Schynige Platte involves approximately 350,000 m³ of massive limestone overlying units of soft marls, dipping at angles of 25 to 30° (Fig. 7). Surface measurements dating back to 1929 indicate that the slope has been moving at a near steady rate of 30 to 40 mm/year (4). Extensometer measurements for the past 10 years (Fig. 8) show a similar trend with minor seasonal fluctuations due to precipitation and snow melt. Keusen (4) notes that the steady nature of the slope displacements over such a long period of time, demonstrates that the underlying instability mechanism involves plastic viscous deformation of the marls.

Figure 7. Profile through the unstable rock mass at Schynige Platte (LEFT – after (4)) and contoured pole plot of bedding and discontinuities (RIGHT).

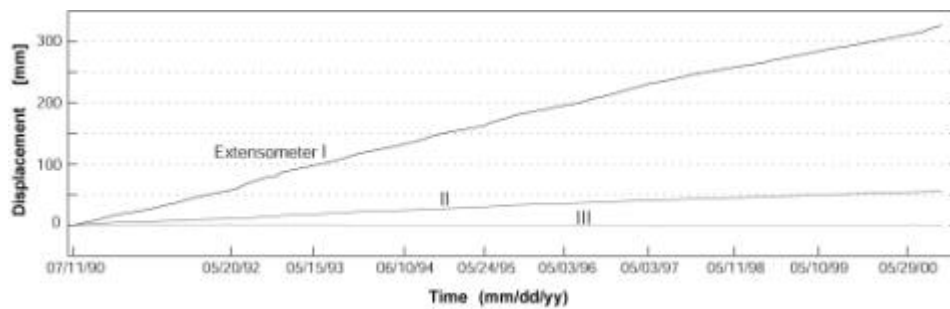
Figure 8. Extensometer measurements corresponding to locations in Fig. 7 (after (4)).

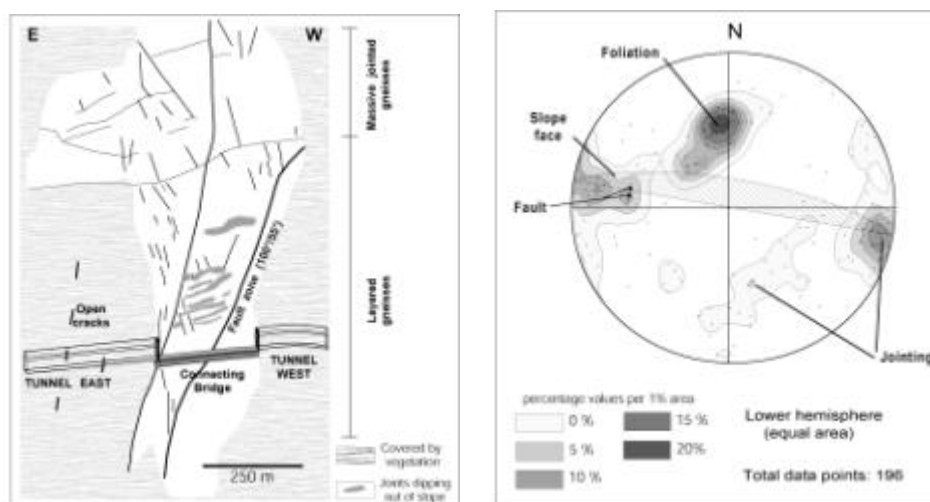
Val del Infern is an unstable rock slope situated within the Penninic gneisses along the Calanca valley in south-eastern Switzerland. The potential rockslide volume of 100,000 m³ endangers a span that includes one of two road tunnels and a connecting bridge (Fig. 9). Surface mapping reveals that the unstable mass is partly delimited by tectonic features. This includes a large fault zone, a near vertical joint set striking perpendicular to the slope face and a minor joint set dipping into the valley (Fig. 9).

Figure 9. Schematic plan view of unstable slope region with surface observations of brittle fractures (LEFT) and contoured pole plot of foliation and discontinuities (RIGHT).

Measurements of surface displacements at Val del Infern, ongoing since 1995, indicate a slope movement rate of 5 to 10 mm/year. The relatively slow displacement rate coincides with the visible and seasonal initiation and growth of new brittle fractures in the gneissic rock mass and tunnel walls. This may suggest, given the kinematically stable orientation of the foliation (i.e. dipping into the slope), that the slope is in an early stage of progressive failure whereby new fractures are slowly propagating and forming a potential shear plane.

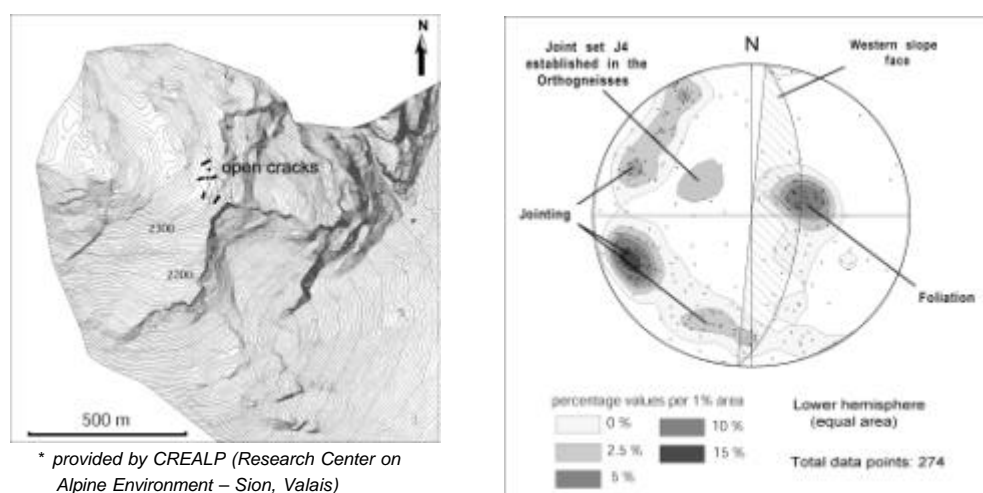
The initial Randa rockslides, previously described, involved the failure of 30 million m³ of rock in two separate events three weeks apart. However, the slope mass is still active and a block approximately 2.5 million m³ is currently being monitored (Fig. 10). Displacements rates of 1-2 cm/year have been measured since 1991. The actively moving rockmass involves massive gneisses alternating with mica-rich paragneisses (Fig. 3) belonging to the Penninic St.-Bernhard nappe. The sliding rock mass is presumably limited by shallow dipping joints (visible at the face) and sets of steep near-vertical joints (Fig. 10). Discontinuities and their role in promoting rockslide instabilities at Randa has been the subject of several extensive studies (e.g. (5)).

Shallow dipping joints, characterized by Wagner (3) as contributing to the 1991 failure, have been denoted as set J4 (Fig. 10). However, these joints appear to be somewhat limited to observations at the slope face and are rarely found during surface outcrop mapping. Tension cracks on surface behind the slope face tend to preferentially open parallel to steeply dipping natural joints. Thus, natural discontinuities are considered to be a major contributing factor to both the 1991 rock slides and the currently monitored slope displacements. Additional outcrop mapping and discontinuity line surveys are planned and will be statistically analyzed to provide a clearer picture of the natural discontinuity distribution and its influence in promoting the instability.

Figure 10. Digital elevation map of Randa showing open tension cracks (LEFT) and contoured pole plot of foliation and discontinuities (RIGHT).

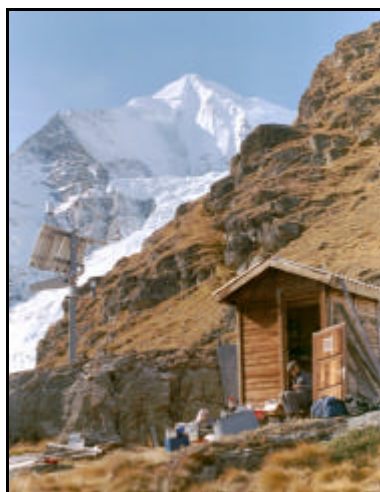
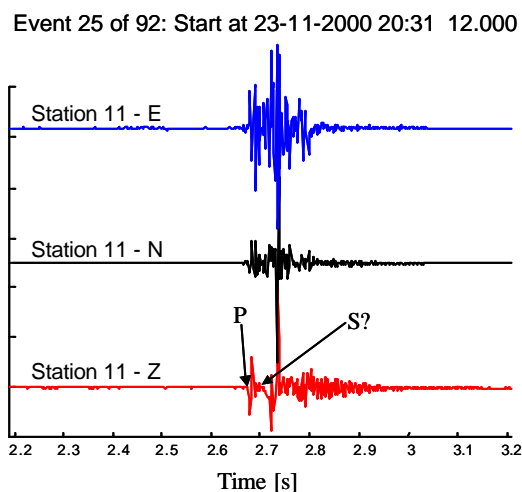
The initial investigations performed at Schynige Platte, Val del Infern and Randa all involved the deployment of surface seismic monitoring systems. A small network of Mars-88 seismographs, provided by the Swiss Seismological Service, was installed and used to monitor signal frequencies between <1 Hz and 200 Hz. Experience gained through this initial survey proved valuable in characterizing the sites with respect to background noise, temperature effects and logistics. For example, heavy vehicle traffic at Val del Infern made monitoring ineffectual and the remote nature of Randa required the installation of solar and wind power supplies (Fig. 11). Of equal importance was the experience gained with respect to seismic activity, data quality and subsurface structure. The remote nature of the Randa site proved beneficial in this respect, given the lack of artificial noise caused by vehicle traffic, allowing for seismic events to be correlated to potential slope activity. During the first months of operation, the seismic network recorded several signals which could be attributed to fracturing in the underlying rock mass (e.g. Fig. 11).

Figure 11: Instrumentation center at Randa (LEFT) and recorded seismic event (RIGHT).
