Internal structure and deformation of an unstable crystalline rock mass above Randa (Switzerland): Part I – Internal structure from integrated geological and geophysical investigations

Heike Willenberg^a, Simon Loew^{a,*}, Erik Eberhardt^{a,1}, Keith F. Evans^a, Thomas Spillmann^{b,2}, Björn Heincke^{b,3}, Hansruedi Maurer^b, Alan G. Green^b

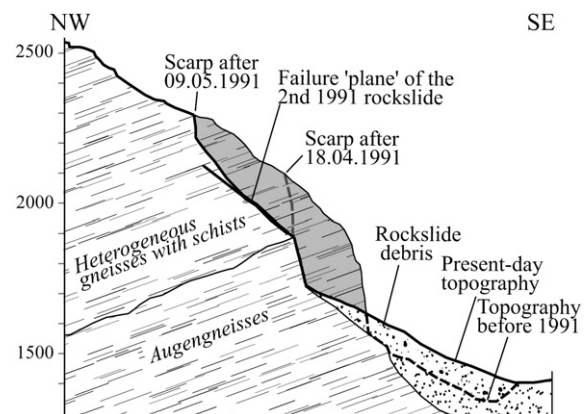
The first event primarily involved the collapse of the massive augengneiss cliff comprising the lower half of the slope (Fig. 2). A large NE-dipping fault close to the valley floor (Fig. 3) has been proposed as the basal shear plane for the first event with subsequent sliding of

Fig. 2. Cross-section of the 1991 rockslides modified after Wagner (1991) and Eberhardt et al. (2004), the failed rock mass is shown shaded. The failure 'plane' of the 2nd event is covered with debris above 1900 m and thus may not be as linear as shown.

and formed a large SE-dipping failure surface (Fig. 2). Rudimentary displacement and fracture monitoring systems installed on the unstable rock mass shortly after the first event provided information

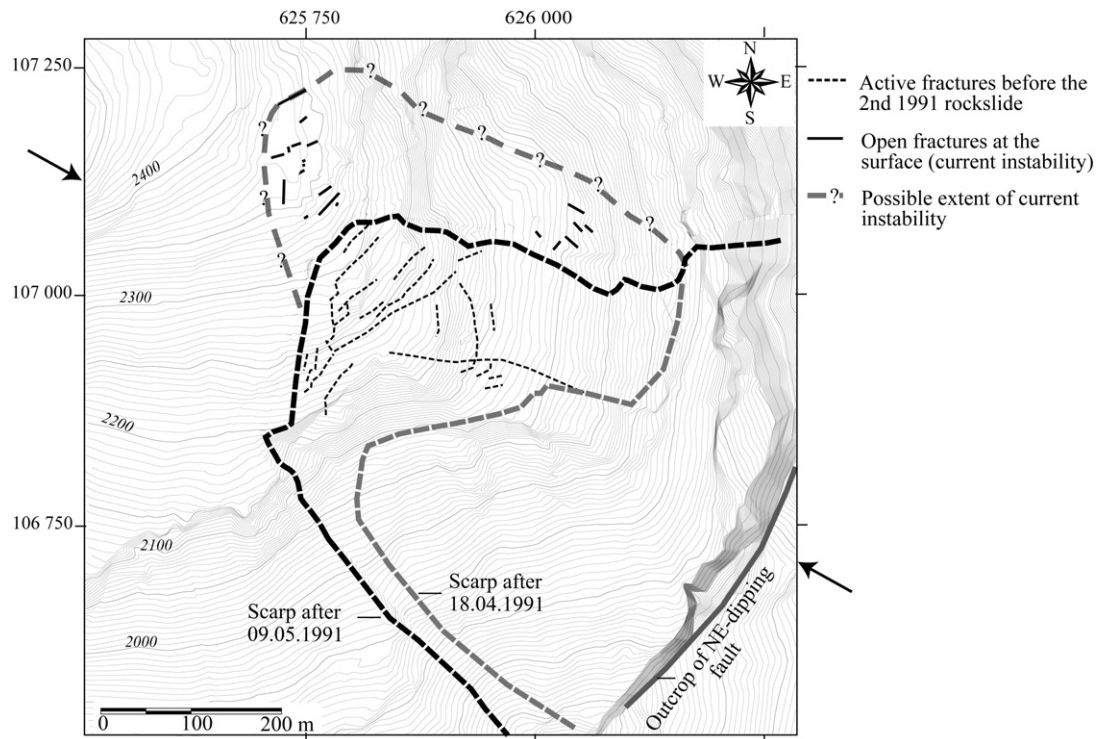
Fig. 3. Topographic map of the project area before the 1991 rockslides. The tops of the scarps of the two main rockslide events (April 18 and May 9, 1991) are indicated. The thin dotted lines are surface fractures that were seen to be active between the first and second rockslide events. The thin solid lines denote open surface fractures on the currently moving rock mass to the north and northwest of the rockslide scarp. The extent of the current instability NW of the 1991 rockslide scarp is based on geodetic monitoring data, which is described in detail in the companion paper (Part II). The NE-dipping fault indicated close to the valley floor is proposed to have acted as a basal sliding surface for the first 1991 rockslide event. The arrows indicate the location of the section shown in Fig. 2.

about the deformation leading up to the second event. Several fractures oriented NE–SW, N–S or W–E were seen to be opening ([Fig. 3](#)) ([Schindler et al., 1993](#)). Further details of this 1991 monitoring network are given in Part II.

Following the 1991 rockslides, the rock mass to the north and northwest of the rockslide scarp has continued to show displacements to the SE at a maximum rate of 2 cm/year. The areal extent of the moving mass shown in [Fig. 3](#) has been constrained with periodically-measured benchmark arrays across surface fractures and geodetic monitoring of a large retro-reflector network ([Jaboyedoff et al., 2004](#); [Ornstein et al., 2005](#)).

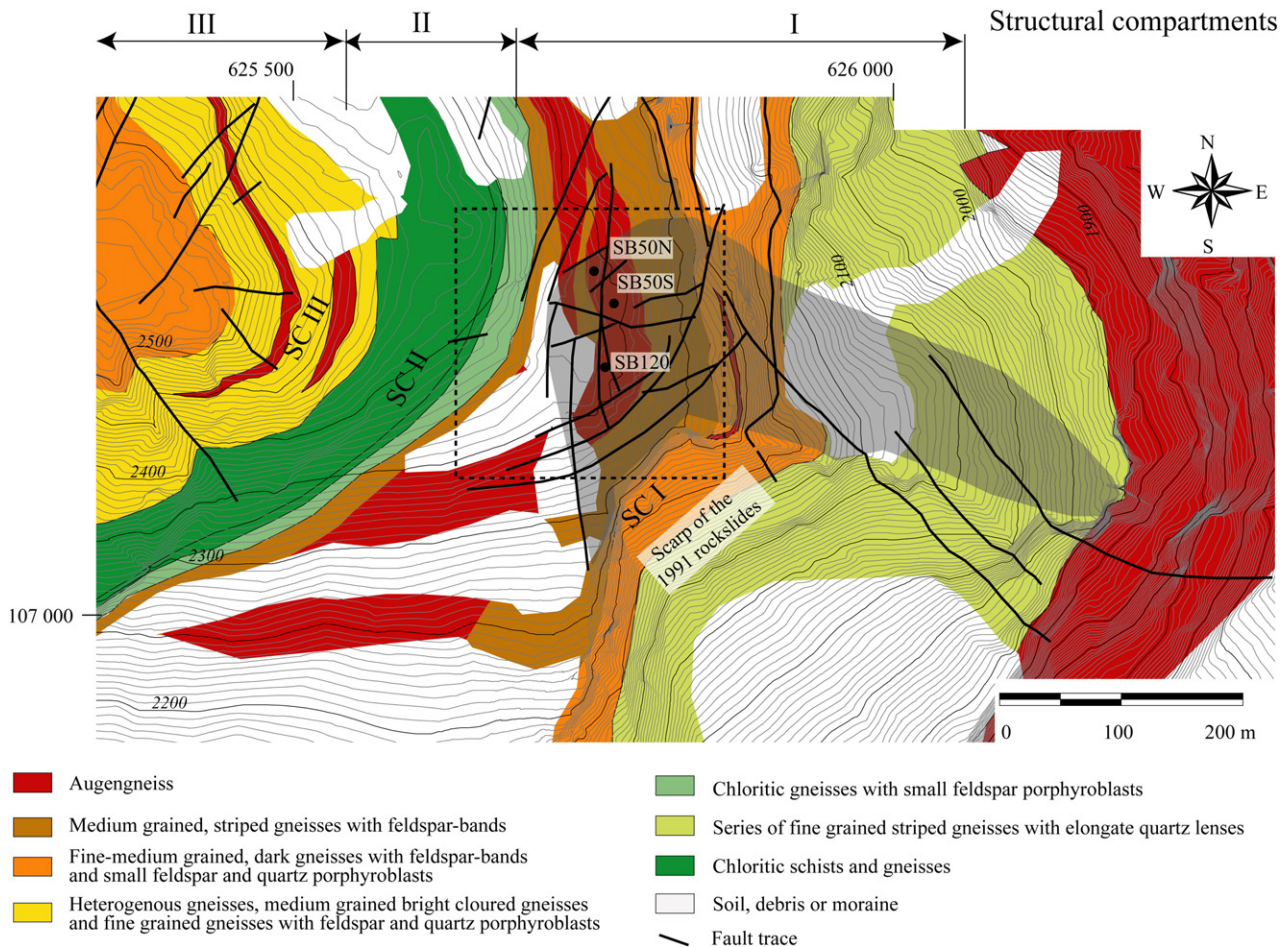
Fig. 6. Traces of surface faults and fracture zones superimposed on a lithological map. The structural compartments indicated at the top of the map correspond to areas with similar small-scale fracture orientations. They generally follow the lithological boundaries. The assumed extent of the unstable rock mass is shown shaded. The dashed box denotes the extent of [Fig. 10](#). The digital elevation model was provided by CREALP.

It is evident from Fig. 6 that the density of faults and fracture zones is higher inside the estimated boundaries of the current slope instability than outside. A close-up of this area is shown in Fig. 10.

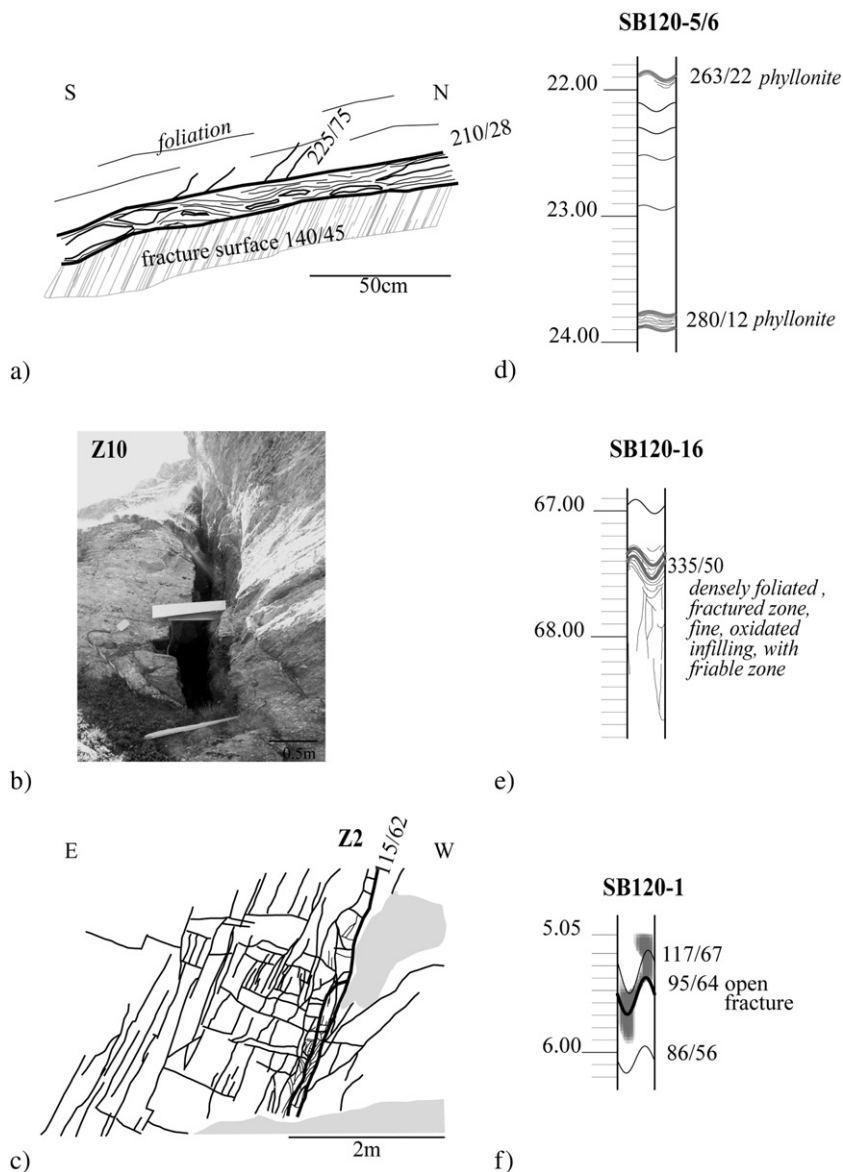
Fig. 9. Outcrop and borehole examples of faults and fracture zones. a) Brittle–ductile shear zone parallel to foliation (set F-1), accompanied by Riedel fractures (top) and set 8 secondary fractures (hatched area below). b) Open surface fracture belonging to an F-2 set fault that is spanned by a crackmeter. c) Brittle–ductile fault of the F-3 set. The central fault core, highlighted by a thick solid line, is accompanied by a fracture zone. d) Sketch of two F-1 faults seen in the borehole OTV logs. Unwrapping of the borehole wall image shows phyllonites oriented parallel to foliation. e) F-2 borehole fault characterised by a 10 cm thick zone of densely foliated and fractured rock. f) Open borehole fracture belonging to an F-3 fracture zone.

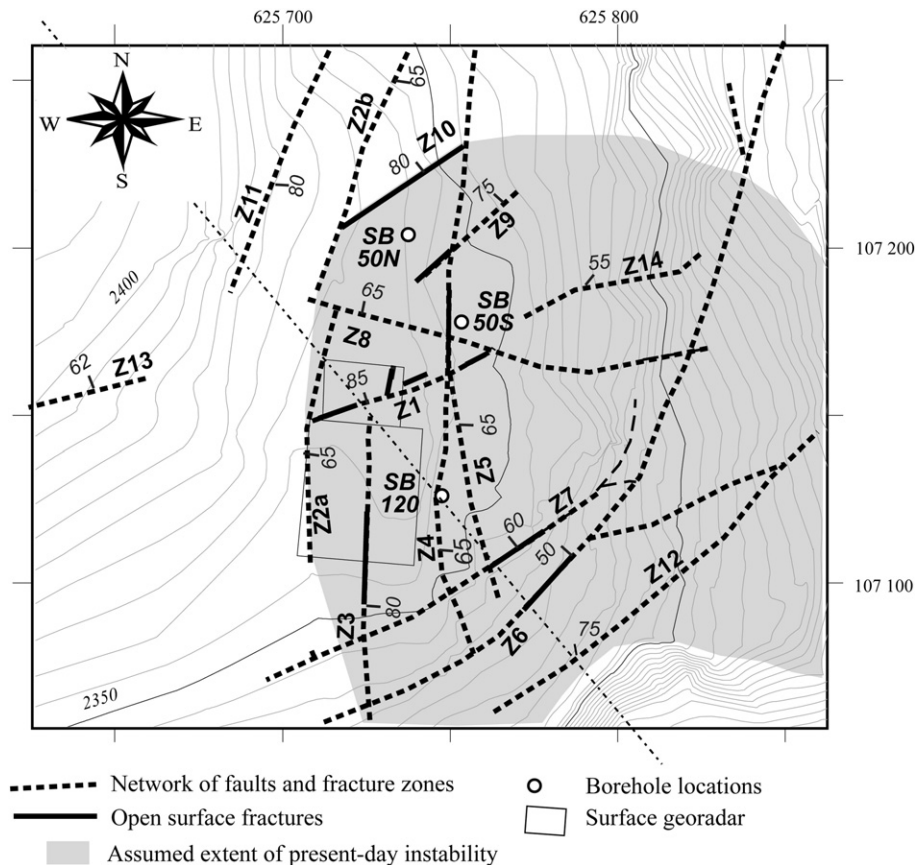
Fig. 10. Detailed map of faults and fracture zones within the study area. Dip direction and dip angles are marked along the traces. Foliation parallel faults (i.e. F-1) are not shown. Open surface fractures are drawn as solid lines. The thin NW–SE dashed line denotes the cross-section through the geological model (and SB 120) used to construct Fig. 17.

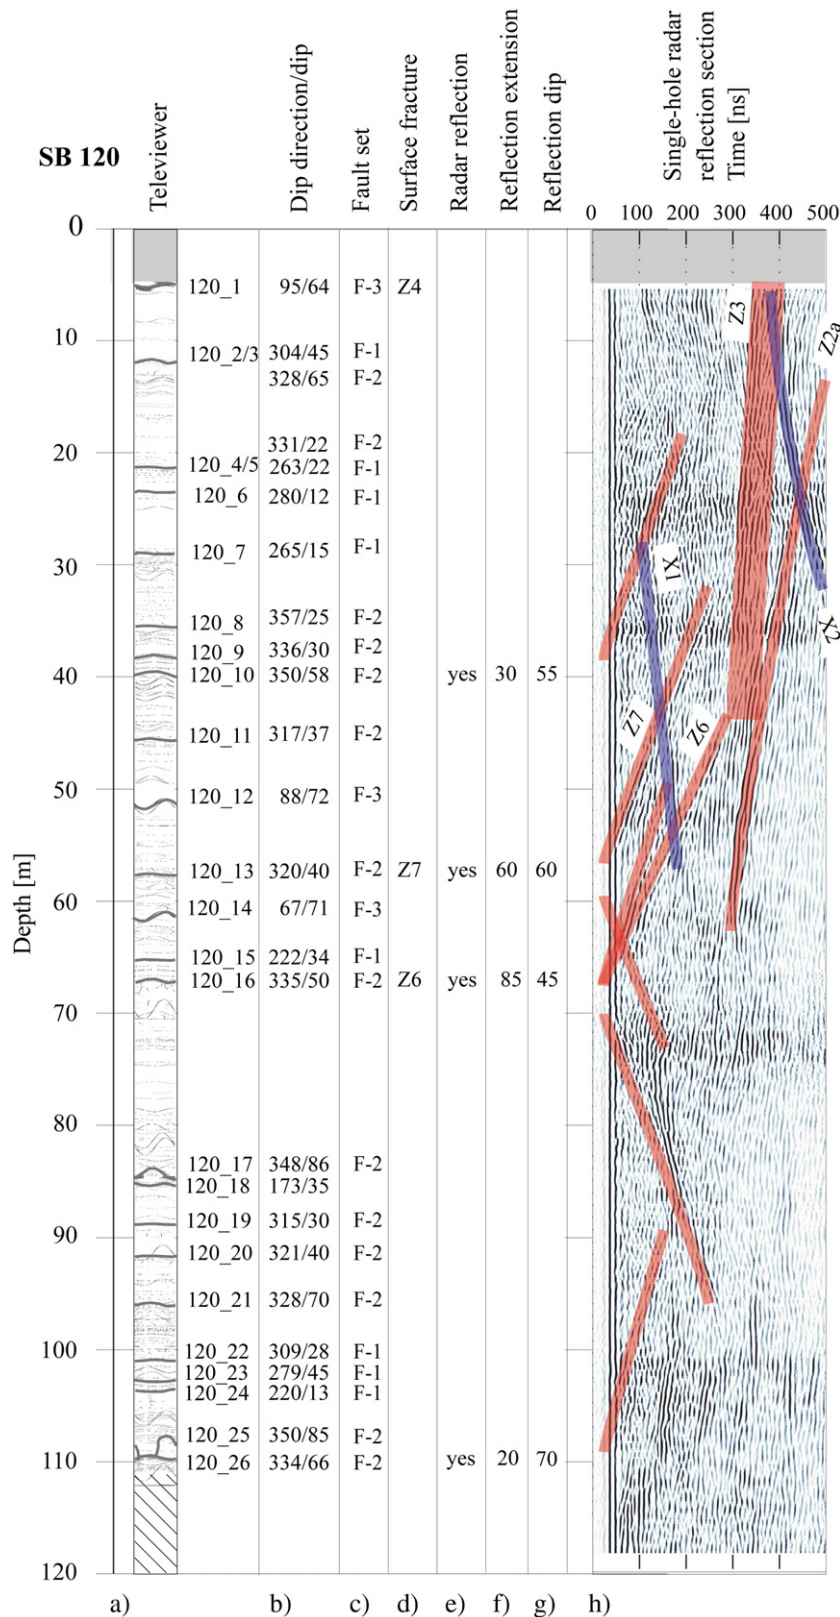
Fig. 11. Summary of borehole fracture data derived from the OTV log together with borehole georadar sections for SB 120. A total of 26 major fractures were identified on the OTV log. Of these, 4 belonging to the F-2 fault set could be associated with reflections in the georadar sections, such that their expression could be traced into the rock mass. a) Unwrapped OTV images of the fracture traces with the 26 major fractures highlighted and labeled. The hatched section below 111 m indicates the borehole was water-filled resulting in degraded image quality. b) Dip direction and dip of the faults and fracture zones. c) Fault set classification. d) Association with faults and fracture zones mapped at the surface, as suggested by geometrical constraints or borehole georadar data. e) Association with georadar reflections (see [Spillmann et al., 2007](#)). f) Minimum extent of the georadar reflections. g) Apparent dip of the georadar reflections. h) Single-hole radar section modified after [Spillmann et al. \(2007\)](#) with the most important reflections highlighted and labeled.

with their identification number, dip/dip direction and the fault set to which they belong. Of the twenty-six major fractures, four were imaged in the borehole reflection data. Two of these, which could be traced over a length of 60 m, were also correlated with surface fractures (120_13 with Z7; 120_16 with Z6). The shallow fracture 120_1 was also clearly associated with surface fracture Z4, but it was not resolved by the radar images. In SB 50S and SB 50N, two major fractures in each borehole could be identified in the georadar sections, two of which could be traced to a surface fault, albeit with some ambiguity (i.e. borehole fracture 50S_2 is connected to either Z4 or Z8, and SB 50N fracture 50N_7 to either Z2 or Z9; see Figs. 12h and 13h).

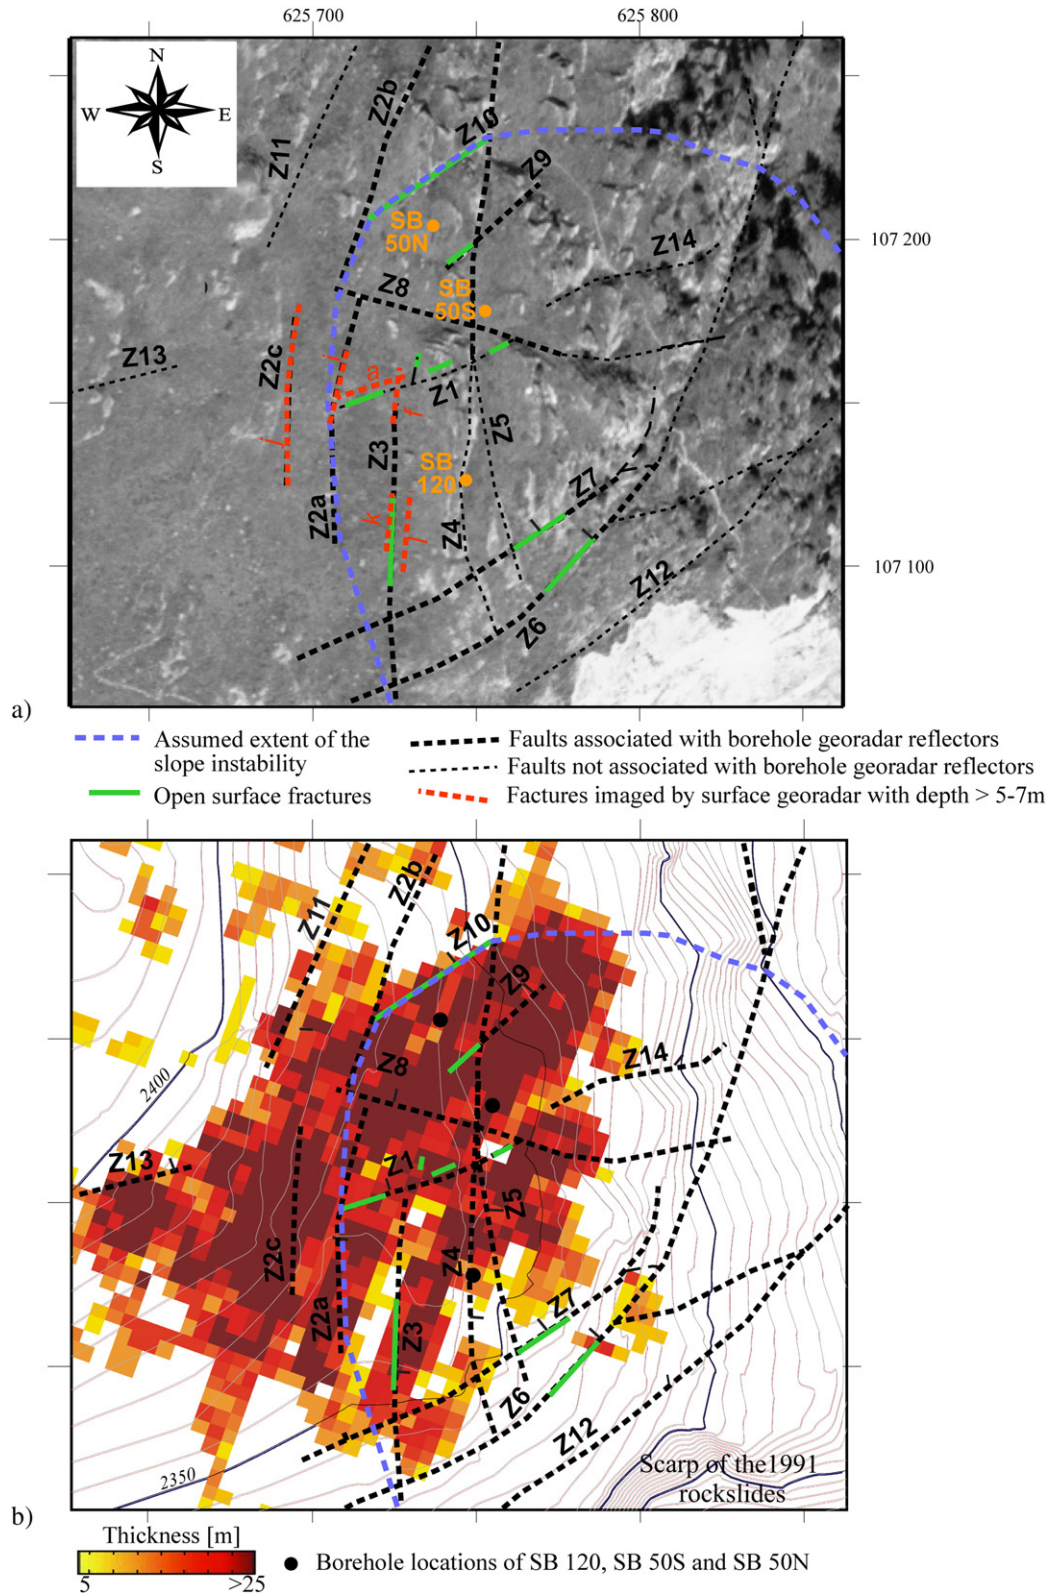
Fig. 14. a) Orthophoto of the study area with an overlay of fault and fracture zone traces inferred from mapping, lineament analysis and/or radar reflection surveys. The assumed extent of the instability is outlined with a blue dotted line. The green lines are segments of the faults and fracture zones that are open on surface. Faults and fracture zones that could be associated with borehole georadar reflectors are highlighted. The red dashed lines are high-angle planes indicated by high semblance values of the 3-D radar survey. The orthophoto is reproduced with permission of Swisstopo (BA068088). b) Thickness of ultralow velocity zones (< 1500 m/s) determined from seismic refraction tomography (modified after Heinicke et al., 2006b) with overlay of surface mapped faults and fracture zones. Thick ultralow velocity zones occur within the estimated boundaries of the unstable rock mass and beyond.

A comparison of fault/fracture zone geometry obtained from surface mapping with data obtained from the borehole OTV images and the various radar reflection structures is given in [Table 1](#) and illustrated in [Fig. 14a](#). The continuity and scale of the faults and fracture zones on the surface suggest that they extend more than 80 m into the subsurface, a result supported by the single-hole radar surveys. Comparison of the dip angles of the radar reflections demonstrates that they generally agree with the mapped dips to within 10°. The dip estimates from the OTV are also in reasonable agreement, the primary discrepancy being for surface fault Z7, for which the OTV dip differs by 20° from that obtained from surface mapping and the borehole georadar data.

shown in [Figs. 14a and 15b](#), largely coincide with faults and fracture zones mapped on the surface and reflectors identified in the single-hole radar data. A surprising result was that the prominent open surface fault Z1 ([Fig. 14a](#)) was seen to coincide with high semblance values in the uppermost 5 m, but not below.

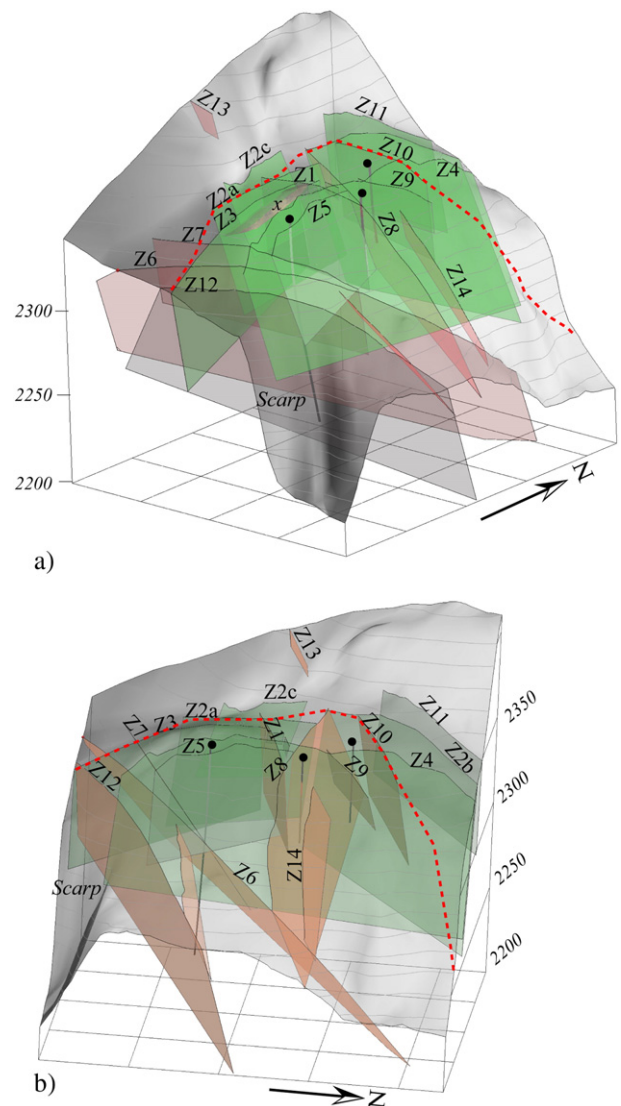
Fig. 16. Geological block model for the investigated area looking: (a) NW, and (b) W. Faults of the NW-dipping set F-2 are shown in red-brown, faults of the E to SE dipping set F-3 are shown in green-grey. The surface denoted 'x' corresponds to the prominent radar reflector shown in yellow in Fig. 15. The red dashed line denotes the assumed extent of the unstable rock mass. The tops of the boreholes are marked by black dots. The cell size of the bottom grid is 50 × 50 m.

depth in SB 120 (Fig. 16b). Further to the NW, these faults are less persistent. The ESE-dipping faults dominate the rock mass near the western boundary of the unstable rock mass. This boundary likely follows the complex zone of faults and fracture zones Z2, Z3, Z2b, Z2c and Z11 (Fig. 16a).

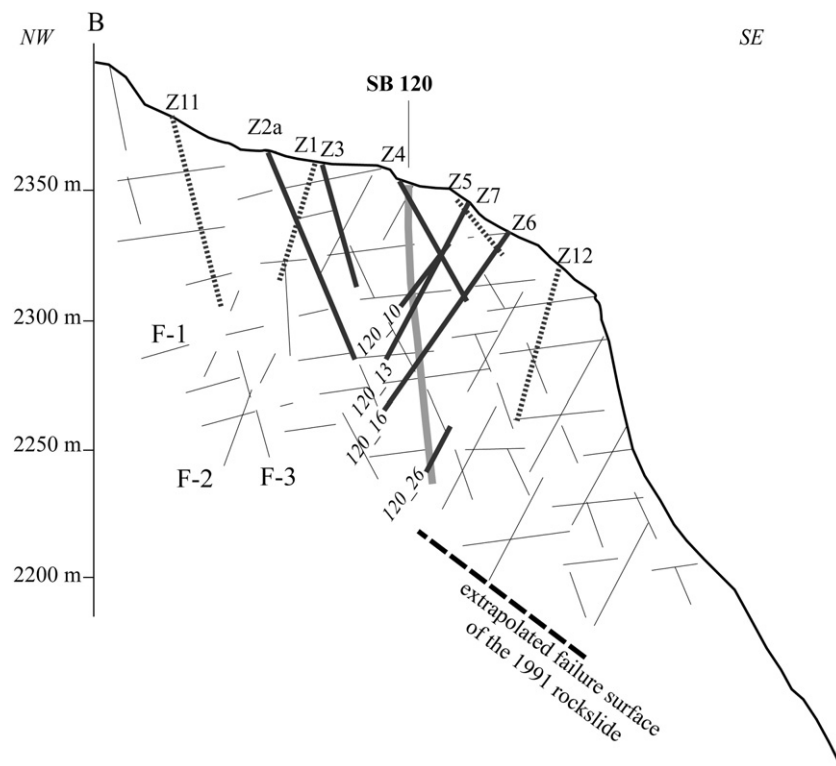
Fig. 17. NW–SE section through SB 120 showing the F-1 to F-3 fault/fracture sets. The location of the cross-section is shown in [Fig. 10](#). Faults and fracture zones mapped by geological and geophysical methods are plotted as bold solid lines. Bold dashed lines indicate the location of surface faults and fracture zones that were not identified on the geophysical data or were situated outside the survey areas. Also shown is the approximate location of the extrapolated failure surface of the second 1991 rockslide, assuming a constant dip angle of 40° parallel to the debris covered failure surface and based on a rare SE-dipping feature on the scarp.
