Adverse Tunnelling Conditions Arising from Slope Instabilities – A Case History

Kuroschi Thuro, Engineering Geology, ETH Zurich, Switzerland
Erik Eberhardt, Engineering Geology, ETH Zurich, Switzerland
Marco Gasparini, Impregilo spa, Italy

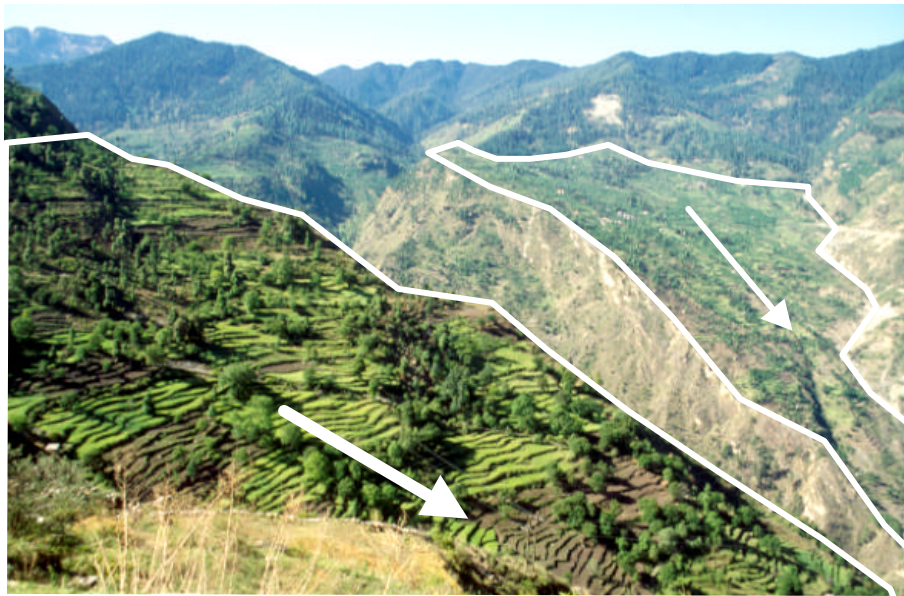
Figure 2. Typical planar sliding surface of a large landslide due to valley-dipping foliation.

Due to foliation parallel sliding planes and cross cutting orthogonal joint systems, numerous landslides and rock falls have occurred in the vicinity of the tunnel works. Figure 2 shows the base of an extensive planar sliding surface, the rock slide debris from which can be found at the bottom of the valley. Features relating to active sliding blocks include deep, open, valley-parallel tension cracks which further suggest creeping mass movements.

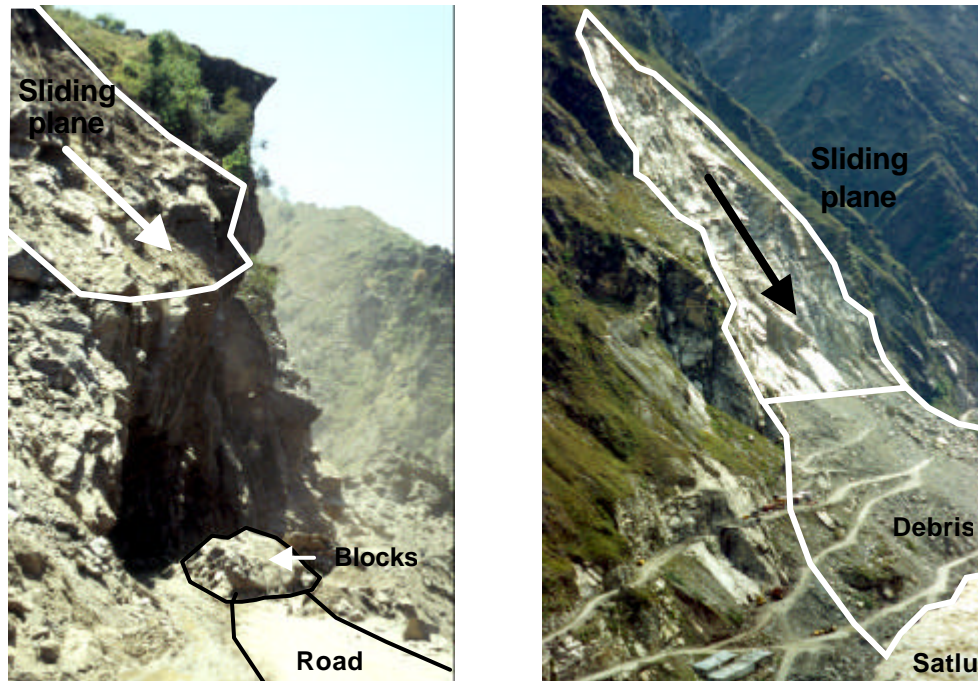
Figure 3. Blocking of the Hindustan-Tibet-Highway by a rock fall (LEFT). Rock slide at the dam site blocking the Satluj River (RIGHT).

The main access road for the project, the "Hindustan-Tibet-Highway", also serves as the primary connecting road in the valley-axis of the Satluj river between the provincial capital Simla of Himachal Pradesh and the nearby city Sarahan. Parallel to the project works, the highway was rebuilt and the slopes supported and cleared of rock debris. Nevertheless, instabilities could not be completely avoided and the road was frequently blocked by both small and large rock falls (Fig. 3 LEFT). These failures resulted in repeated closures of the highway for hours and sometimes days, leading to major traffic jams and affecting project-based traffic. Tragically, a project engineer and two members of his staff were buried under the debris of one such rock fall.

Access roads and access tunnels built at 5 – 6 km intervals perpendicular to the headrace tunnel alignment and intersecting the valley wall, were greatly affected. Rock falls at these locations frequently endangered surface works and workers. The access tunnel “Daj Khad” had to be abandoned completely after 3 months due to severe stability problems, relating to the portal being located within a creeping rock mass consisting of fractured and weathered material. This required the tunnel adit to be relocated to a more favourable position. Similarly, the works at the dam site and intake were delayed for over one year by a rock slide that blocked and dammed the river (2). Water heights reached 10 m behind the rockslide dam at this narrow location (Fig. 3 RIGHT). Afterwards, costly scaling works along the slope and the clearing of the river bed were required before the abutments of the dam could be exposed.

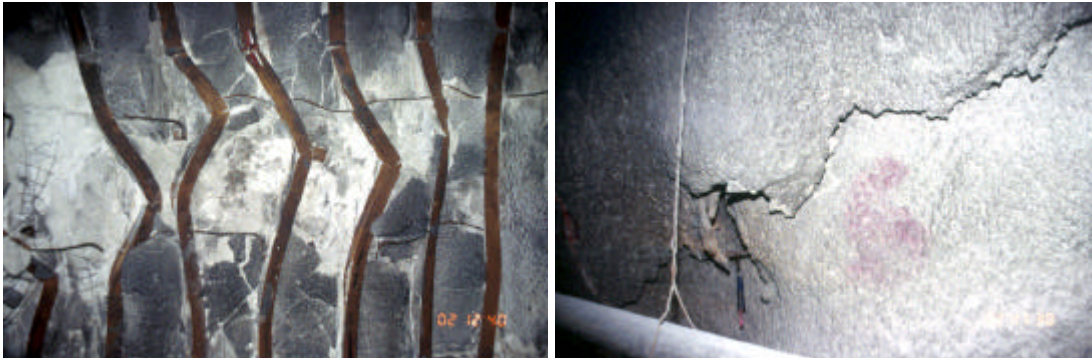
Figure 4. Buckling and bending of 150x150 mm steel ribs with steel lining between crown and right spring line (LEFT). Shearing of shotcrete lining along left bench (RIGHT).

atic along intervals with high rock cover. Examples of the type of damage encountered can be seen in Figure 4 Cracks in the shotcrete developed shortly after installation of the support with deformations continuing for longer periods of time. As a consequence, the support along certain sections had to be stiffened by additional wire mesh, steel ribs, shotcrete and rock bolts or welded steel beams.

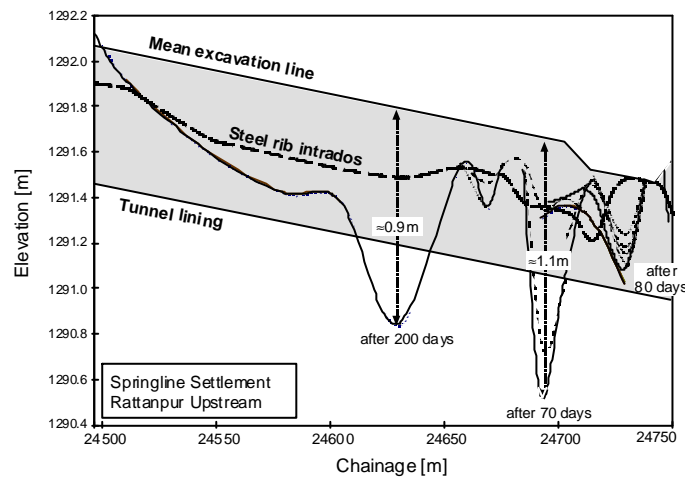
Figure 5. Recorded settlement of the crown / spring line versus absolute elevation in the headrace tunnel near the Rattanpur adit intersection.

Figure 5 shows the typical springline settlements observed during the excavation period. The two parallel lines show the thickness between the mean rock excavation and the inner tunnel lining versus absolute elevation. The recorded maximum settlements are provided with the time of measurement following excavation indicated below.

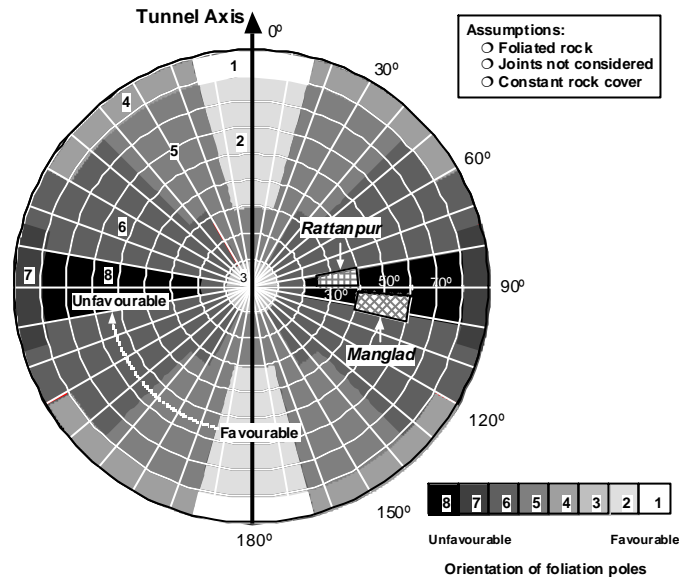
Figure 7. Pole plot of favourable and unfavourable orientations, with respect to foliation, versus tunnel axis alignment.

The orientation of the schistosity was found to be unfavourable with respect to the axis of the Rattanpur and Manglad headings. In Figure 7, favourable and unfavourable orientations of foliation versus tunnel axis are shown. The Manglad and Rattanpur headings of the headrace tunnel plot in the “highly unfavourable” area of the stereo net. In these headings the foliation is nearly parallel to the tunnel axis and dipping at an angle of 25° to 60°.

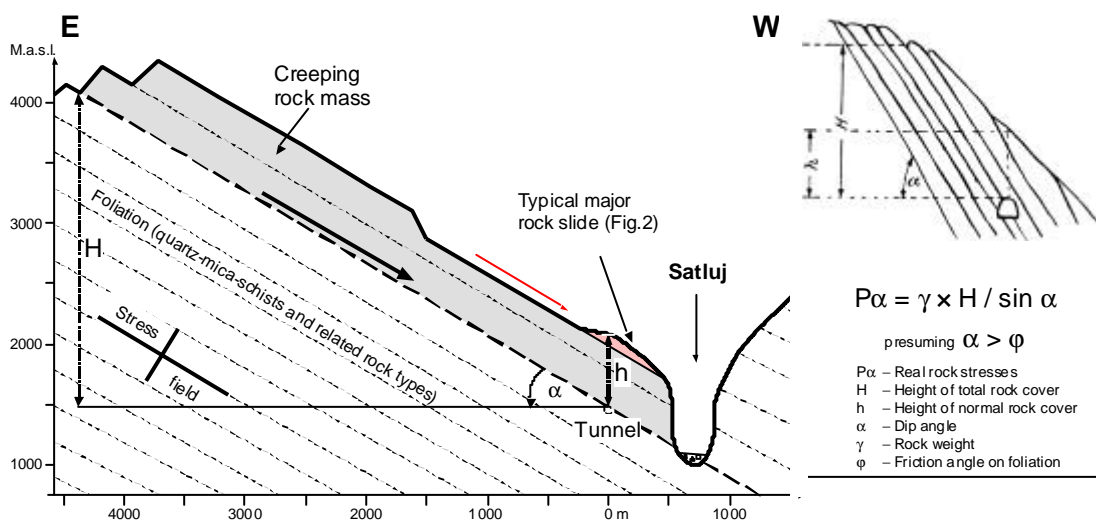
Figure 8. Cross section of the headrace tunnel and mountain valley showing the assumed *in situ* stress conditions (LEFT). Influence of inclined schistosity on the *in situ* stress condi-

tions of a valley tunnel after Stini (3) and calculation of real rock stresses $P\alpha$ (RIGHT). Analytical estimations of *in situ* stress based on overburden loading can be adjusted to account for the dip angle of the structure (Fig. 8). However, these calculation methods do not consider several key factors, e.g. cohesion, and provide largely conservative overestimations of the acting rock stresses.

The primary underlying factor for this unfavourable condition is the alignment of the far-field stresses as illustrated in Figure 8. This figure shows a cross-section through the mountain valley and the location of the NJHP headrace tunnel as it appears near one of the intersecting access tunnels. Slope instabilities (shaded grey) involving downslope creeping displacements along the dipping foliation, is believed to be controlled by slope angles steeper than the expected angle of friction. Furthermore, observations have been made of several active landslides above the tunnel alignment showing visible open cracks within the body of the slope. It is likely that these

Tunnelling in high stress conditions close to steep valley walls have been reported by various authors (e.g. 3). Given the topography and orientation of the geological structure, the major principal stress would be expected to be aligned parallel to the slope. Thus simple calculations of stress based on overburden loading are not applicable. High stresses parallel to the slope are also believed to be contributing to the instability of the slope. Furthermore, rapid uplift of the Himalaya may factor into the observed phenomenon.

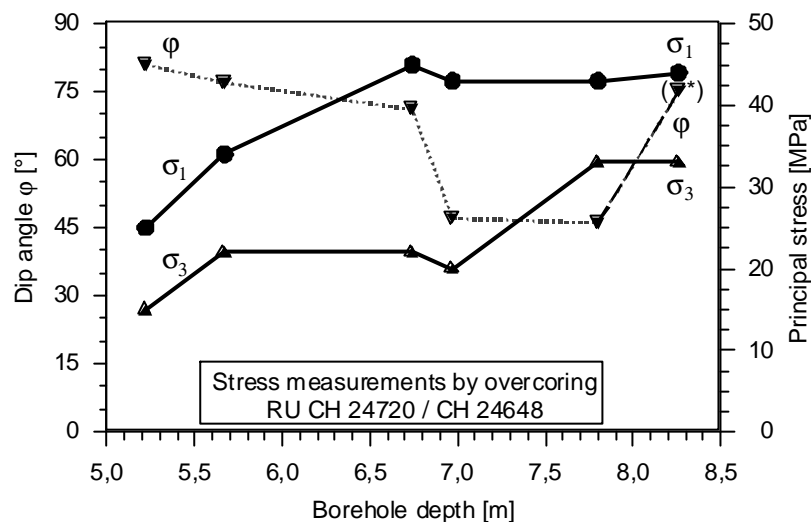
Figure 9. Stress measurements by overcoring performed in “Rattanpur Upstream”. Legend: * disturbed, σ_1 – major principal stress, σ_3 – minor principal stress.

To better understand the *in situ* stress state, a series of overcoring measurements were made (Fig. 9). These tests were performed in horizontal boreholes drilled into the uphill tunnel wall and face. The results show increasing stress values with depth and reorientation of the major principal stress axis towards the dip angle of foliation (approx. 40°).

The distinct-element program UDEC (4) was used to investigate the effects of slope displacements on potential tunnel instability mechanisms. Of particular concern was the role that foliation, and fractures parallel to the foliation, play when driven by small-scale velocities derived from slope mass movements. Two series of models were generated, one examining the large scale instability of the slope (Fig. 10) and one focussing on smaller-scale deformations of the headrace tunnel (Fig. 11). Through this combined modelling process, results from the large-scale models were used to constrain boundary conditions for the detailed tunnel model (e.g. slope velocities). The detailed analysis was performed for two different scenarios based on variations in the geological structure, i.e. foliation joint spacings of 1 m and 0.5 m parallel to the slope surface (Fig. 11). Material properties were used based on laboratory and *in situ* testing campaigns performed for the Nathpa Jhakri Hydro Project. Table 1 includes the material properties used, where variations in the normal and shear stiffness values reflect variations in the finite-difference element dimensions across different element zones. Initial stress conditions were incorporated based on values determined through *in situ* overcoring measurements (Fig. 9).

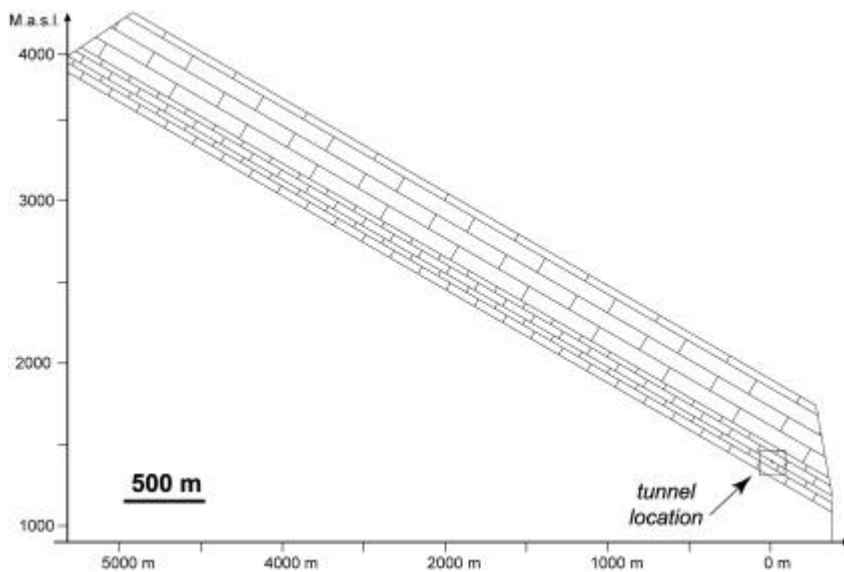
Figure 10. UDEC Model for the large scale instability of the Rattanpur slope section.

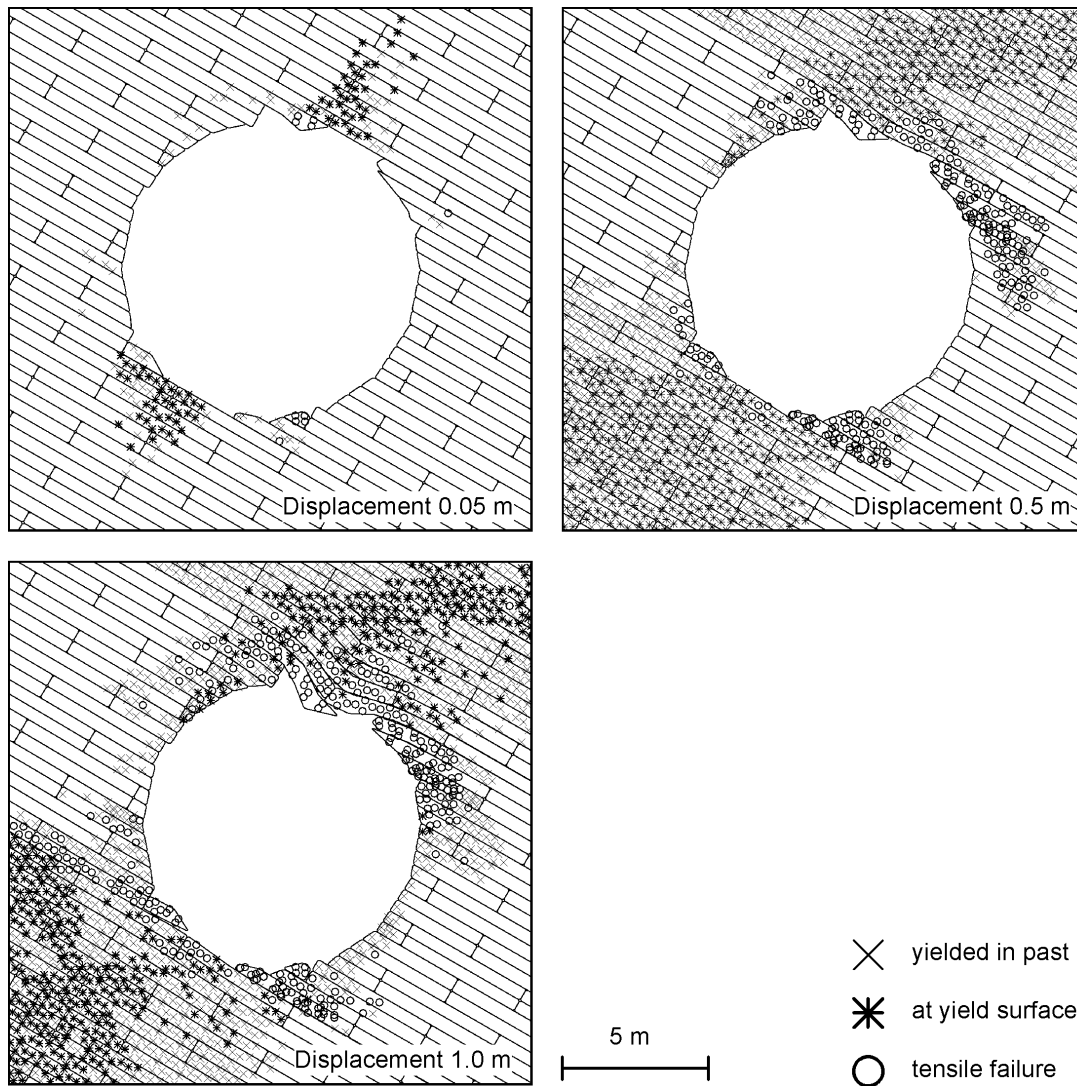
Figure 12. Progressive stages of tunnel failure for down-slope displacements of 0.05 m, 0.5 m and 1 m, respectively. Note that the tunnel diameter is 11 m.

Results from these models show that the tunnel remains stable if the slope conditions are also in a stable state. However, if the slope is unstable, subsequent slope movements begin to induce buckling failures in the tunnel roof once down-slope displacements exceed 0.5 m. Figure 12 shows the progressive stages of tunnel failure after down-slope displacements of 0.05, 0.5 and 1 m, respectively. This correlates well with *in situ* observations (Fig. 6).

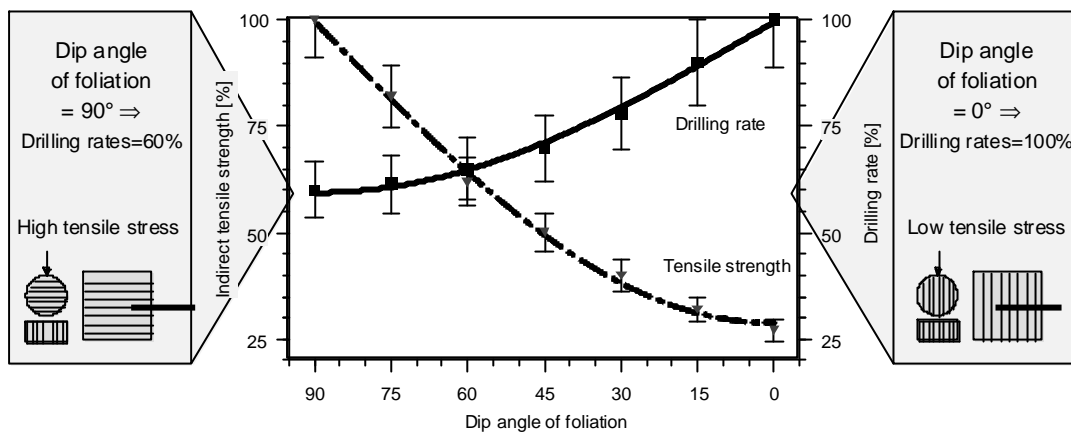
Figure 13. Drilling rate and tensile strength plotted against foliation orientation for quartz-mica-schists (after Thuro (5)).

corded when drilling parallel to schistosity as opposed to those for the perpendicular case. Figure 13 for example indicates the close relationship between drilling velocity and tensile rock strength as a function of foliation angle. This figure clearly shows, that the tensile strength parallel to orientation (load perpendicular) is relatively high and the corresponding drilling rates are low. Blasting conditions can also be related to drilling rates, and, in cases where the tunnel axis was oriented parallel to the main foliation, poor blasting conditions were encountered (6).
