Primary sliding mechanisms in dipping interbedded conglomerates and marls

M.Luginbuehl, E.Eberhardt & K.Thuro

Engineering Geology, Swiss Federal Institute of Technology (ETH Zurich), Switzerland

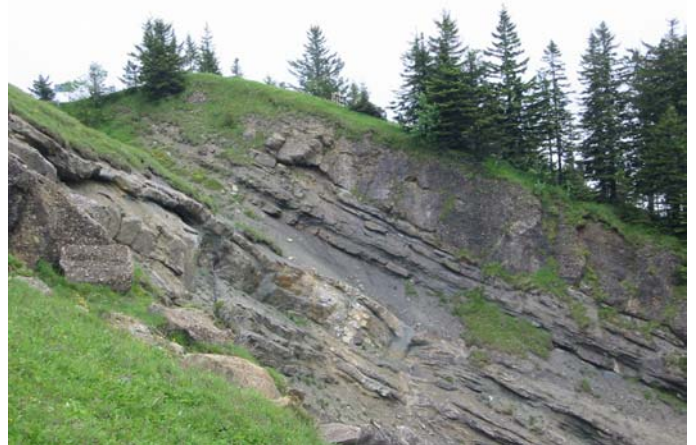
Figure 1. Lateral release margin at the top of the Goldau rockslide showing interbedded conglomerates and marls dipping at angles between 15° and 30°.

failing along bedding plane contacts with the underlying marls (Fig. 1). Given the kinematic feasibility promoted by the geological conditions, it isn't surprising that earlier failures preceded the 1806 event, including one in 1354, and that remnants of prehistoric slides cover the lower Rossberg slopes (Eisbacher & Clague 1984). Following the 1806 event, smaller slides have also occurred, notably in 1874 and 1910, the latter involving the reactivation of old slide debris (Heim 1932).

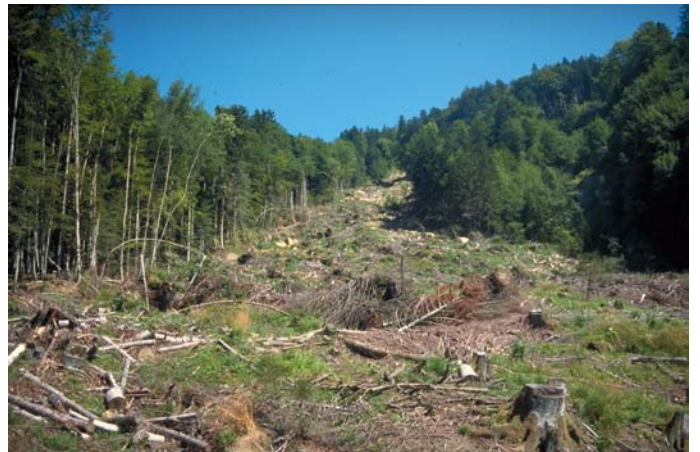
Figure 3. Travel path of the 1999 Rufi slide.

The slide events involved the mass movement of surficial soils, weathered slide debris (accumulated from previous slide events) and intact rock, over a down slope distance of approximately 800 m (Figs. 2-3). According to local reports, the primary rock-slide occurred suddenly overnight carrying with it a 30 m stretch of road. Asphalt from the road was found 150 m downslope (Fig. 4). The failed mass then came to rest on top of an older inactive debris slide, also saturated by the heavy precipitation, reactivating it. Damage resulting from the reactivation of the lower debris slide body was mostly in the form of destroyed or disturbed forest and pastureland. Total damage relating to the slide included the destruction of a paved road and 1 km² of forested and pastured land.

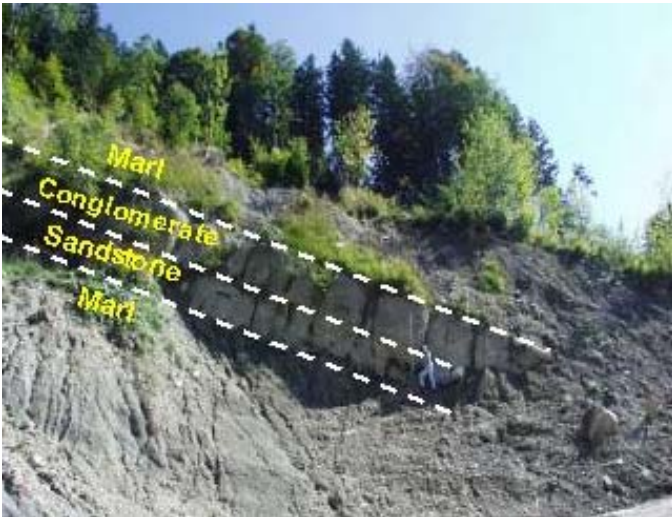
Figure 5. Bedding sequence of the interbedded conglomerates and marls along the margin of the Rufi slide.

ited within a continental alluvial fan environment and consist of a series of interbedded conglomerates, sandstones, and marls (Fig. 5). The conglomerates make-up approximately 50% of the conglomerate-sandstone-marl sequence thickness. Most of the clasts in the conglomerate are derived from dolomites and limestones from the prealpine nappes, and show fining upwards. The relative strength of the conglomerates makes them more resistant to weathering resulting in the formation of cliffs with heights of 2 to 20m (Fig. 6). The sandstone consists of coarse-grained, cross-bedded lime sand. It appears gray in colour when weathered and brown when fresh. The marls are gray to bluish gray in colour and are highly susceptible to weathering. Laboratory testing shows that the carbonate content of the marls belonging to the Rufi slide is in the range of 40 to 50%.

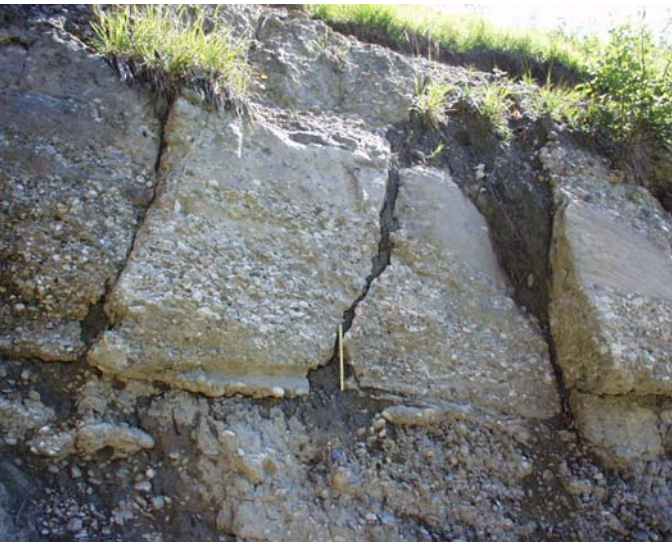
Figure 6. Cliff-forming conglomerates showing subvertical joints.

The tectonics of the investigation area are representative of the subalpine Molasse, consisting of thick overthrustured layers which were pushed over by the folded Helvetic nappes. For this reason, the different tectonic units are easily differentiated. In the slide area the bedding layers dip to the southwest and are cross-cut by near-orthogonal joint sets (Figs. 6-7). These joints, found primarily in the con-

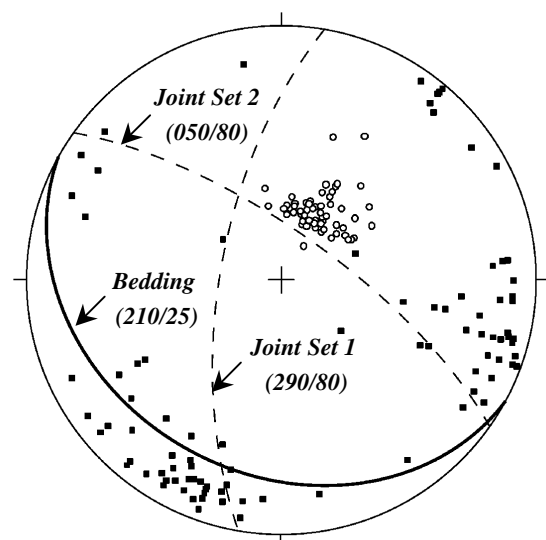
Figure 7. Equal area stereonet plot of discontinuities measured along the Rufi slide boundaries (\circ = bedding plane; \blacksquare = joint; dip direction/dip).

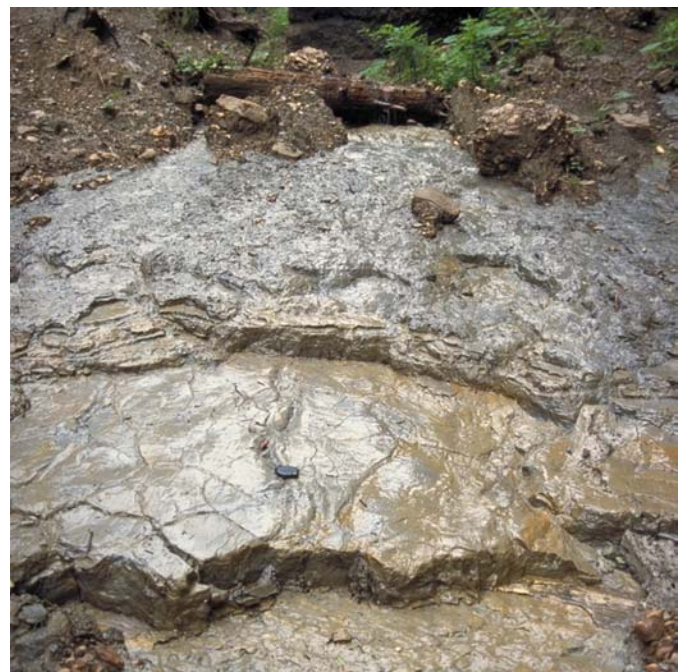
Figure 9. Upper Rufi slide surface through marl layers.

Examination of the slide scarp and lateral boundaries indicates that the thickness of the conglomerates was approximately 2 m at the head of the slide. It is at the back scarp that the slide surface most closely coincides with the contact between the conglomerate and marl. The sliding surface in this upper section is planar dipping at approximately 22°. Moving down slope, the slide surface slowly cuts down into the marls in a step-like fashion (Fig. 9) over a slope length of 100-200 m.

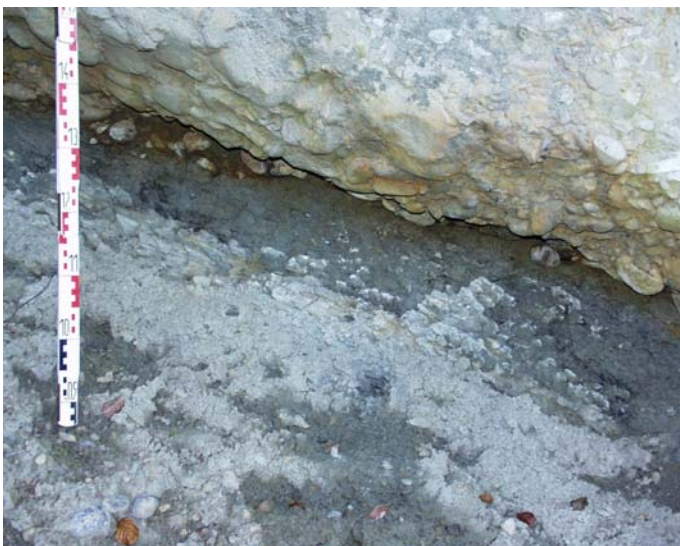
Figure 11. Conglomerate block overlying weakened weathered marl.

marls in the slide area based on designations by Einsele et al. (1985). The degree of weathering of the marl below the slide surface was characterized as W1 (slightly weathered). The upper marl layers constituting the slide body range in their weathering state from W2 to W5 (moderately weathered to residual soil). Field observations suggest that the more defined the weathering contrast between the marl layers, the greater the tendency for overlying conglomerate blocks to creep along the weak interfaces or incompetent layers (Fig. 11).
