The Afternoon Creek rockslide near Newhalem, Washington

Abstract A series of mass wasting events occurred above a Washington, USA, highway in the Cascade Mountains in November and December 2003. The largest event was a rockslide involving approximately 750,000 m³ that occurred on November 9, 2003. The source zone for this event was located at the crest of a ridge. Most of the debris fell to the east of the sharp ridge and was deposited in the relatively shallow sloping Afternoon Creek without causing damage to the highway. Lesser amounts of debris fell to the west of the ridge, sliding 600 m down the steeper Falls Creek and impacting the road. There is an evidence of one or more historical rock avalanches at this location. Displacement of reference points, ground vibration, crack extension, and tilting are being monitored due to concerns that future slope failures or remobilization of debris might again damage or block the highway.

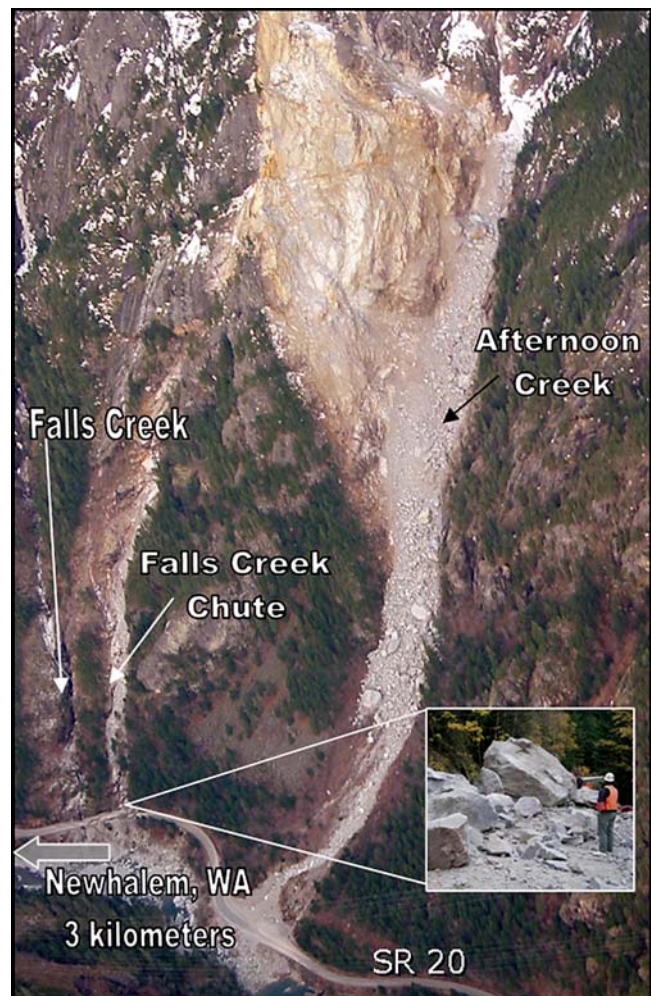
Fig. 1 Afternoon Creek rockslide above SR 20 near Newhalem, WA. Photograph provided by John Scurlock, Concrete, WA

On November 9, 2003, a rockslide occurred above Washington State Route 20 (SR 20) near Newhalem, Washington, USA. Rock avalanche debris fell more than 600 m in elevation down Falls Creek, Falls Creek Chute, and Afternoon Creek (Fig. 1). Most of the debris (approximately 750,000 m³) fell to the east of a sharp ridge and was deposited in the relatively shallow sloping Afternoon Creek without causing damage to the highway. Lesser amounts of debris fell to the west of the ridge down the steeper Falls Creek and Falls Creek Chute. Much of this material traveled all the way to SR 20, destroying portions of the roadway and guardrail, and depositing up to 4-m diameter boulders on the road. This rockslide was followed by a series of smaller mass wasting events in November and December 2003.

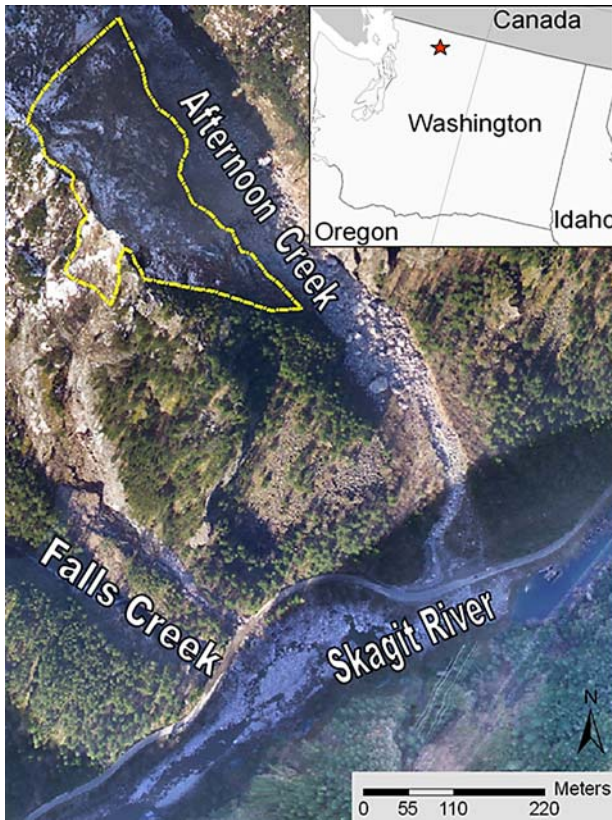
Fig. 2 Location of Afternoon Creek rockslide. Three kilometers east of Newhalem, Washington, USA. Failure area outlined in yellow

range in the USA. Afternoon Creek is located in the heart of these exceptionally steep and rugged mountains (Fig. 2); the peaks near the Afternoon Creek rockslide have nearly 1600 m of vertical relief.

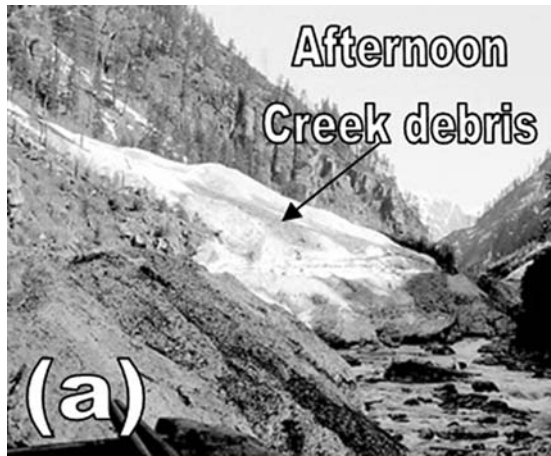
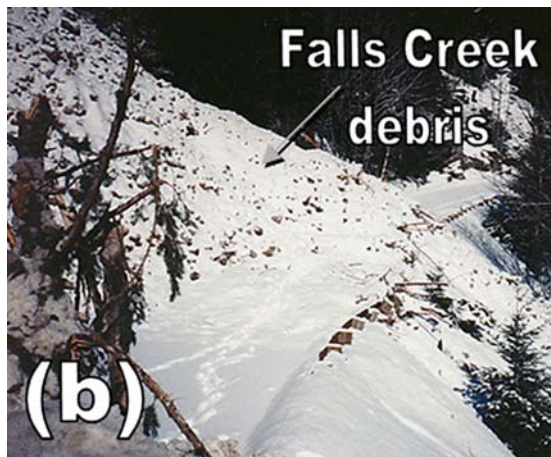
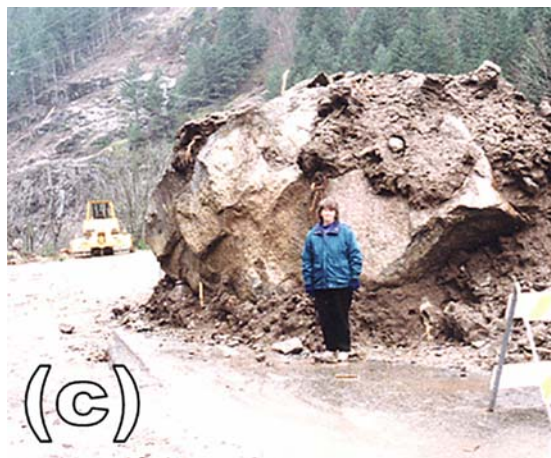
Fig. 4 Historical photographs of debris flows that reached the state route 20 highway. **a** Afternoon Creek debris flow material (March 23, 1949). **b** Falls Creek Chute debris flow covered with fresh snow (1990). **c** Afternoon Creek (1999 or 2000). Photographs provided by WSDOT

Debris flows and snow avalanches are common to both Afternoon Creek and Falls Creek and have forced road closure on several occasions in the past (e.g. Fig. 4). Although the November 9, 2003 event was the first large rock avalanche on record, undated photographs and aerial photos from 1998 indicate ongoing rock fall activity several years before the event. Significant rock fall scars near the top of the slope and fresh boulder-sized debris in Afternoon Creek can be seen in undated oblique photographs (Fig. 5). Rockfall scars of the same magnitude can be seen in aerial photos taken in 1998. Some of the rock rubble that is now covered by vegetation (Fig. 5) may be debris from a single rock avalanche, or a series of historical rock avalanches that have occurred since deglaciation (late Pleistocene). This evidence indicates that slope instabilities in the form of isolated rockfall and larger rock avalanches are common in Afternoon Creek since deglaciation.

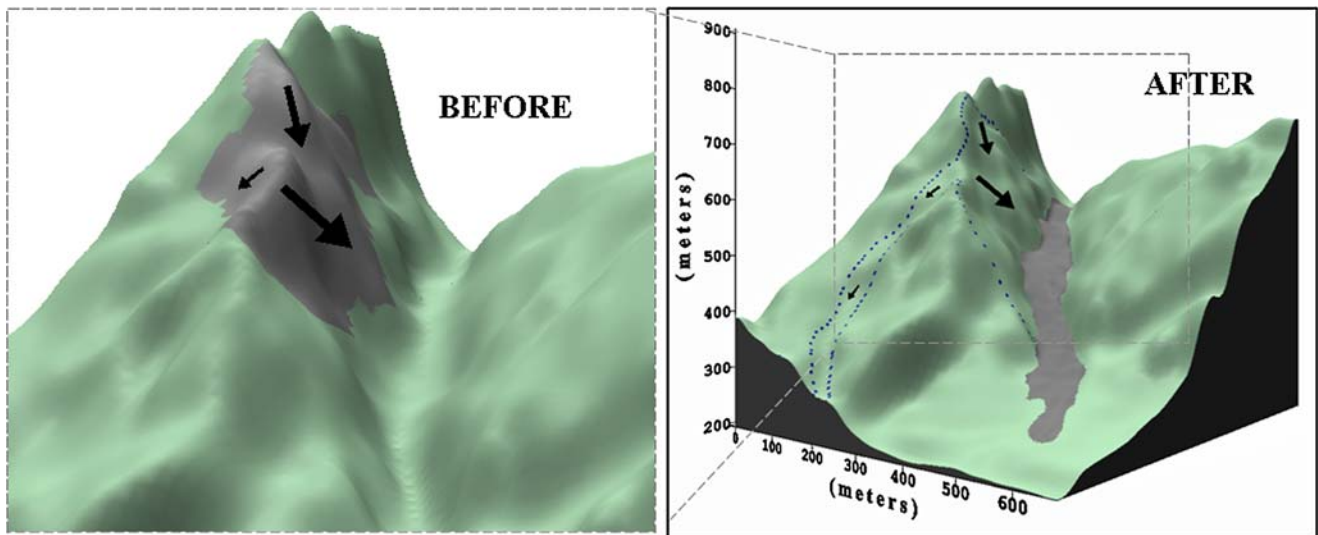
Fig. 7 Digital elevation model of the Afternoon Creek rockslide. Unstable mass is shown in gray. Arrows indicate direction of movement. Dotted blue line indicates the extent of path

The failure mechanism of the November 9, 2003 rockslide is complex. A preliminary interpretation is that the initial collapse occurred in the southern half of the failure zone where the rock mass is most highly fractured and dilated. This material collapsed toward Afternoon Creek. The event unloaded the toe of the larger, more competent blocks that slid on plane A, initially in a direction parallel/oblique to Afternoon Creek (Fig. 6). Rockfall and/or toppling in the upper portion of the failure zone followed after the loss of lateral support provided by the large blocks. Plane B (parallel to Afternoon Creek) allowed toppling and provided the lateral release necessary for planar sliding. Given the geometry of the ridge, a small percentage of the total rockslide material (<10%) traveled down the west side of the ridge along Falls Creek and Falls Creek Chute impacting the highway below (Fig. 7).
