# **JASPER WILDFIRE:**

# **COMMUNITY IMPACT RESEARCH**

Project number: 301016432 Report number: WF TR 2025 N4

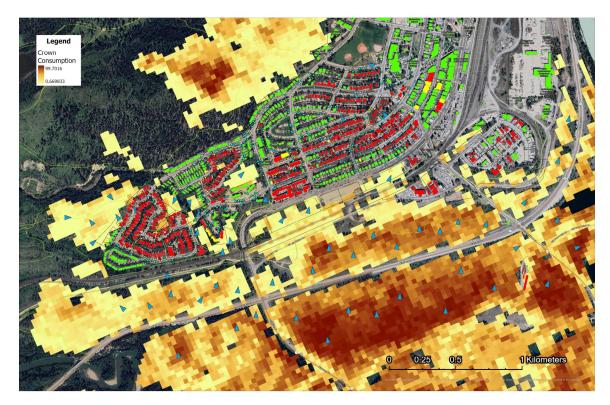
All structure ignitions north of the railway and Connaught drive were caused by wildfire embers and not direct flame or radiant heat. There was sufficient distance to eliminate potential for ignition due to direct flame contact or radiant heat in the transition to the urban area. However, there was evidence of potential pockets of forested areas threatening structures if defensive actions had not taken place along the cabin creek ravine. There was evidence that the northwest structure in the Patricia Place neighbourhood ignited due to a spot fire that started in the ravine and burned up to the northwest corner of the structure. Other than this location the other ignitions were started due to embers from the wildland or urban area as there were unburned green sections or large fuel free zones at the WUI of the other areas. Once the embers from the wildland started the urban conflagration, ignition of new structures was due to structure-to-structure radiant heat and flame progression or embers from upwind structures combined with wildland embers.

Figure 4: Jasper townsite. The degree of canopy consumption is shown with the coloured pixels while fire spread direction is shown with the blue arrows. The structures that are green have no easily visible fire damage, yellow have visible fire damage, and red are destroyed. Vehicle locations and condition represented by round dots following the same colour scheme as the structures.

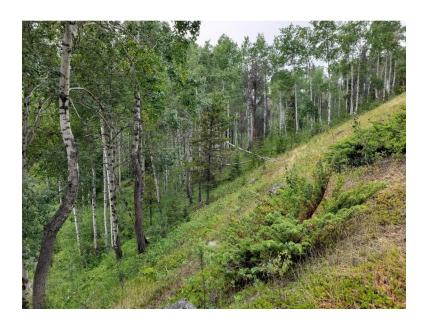
Figure 5: Forest area surrounding the most southwest portion of the Jasper townsite.

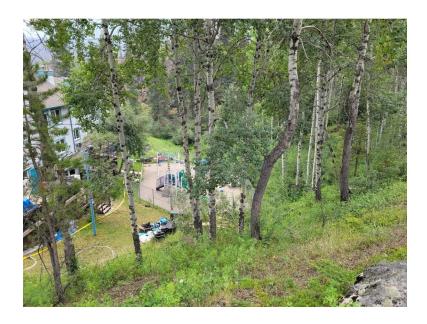
Figure 6: View looking south of the forest area surrounding the most southwest portion of the Jasper townsite.

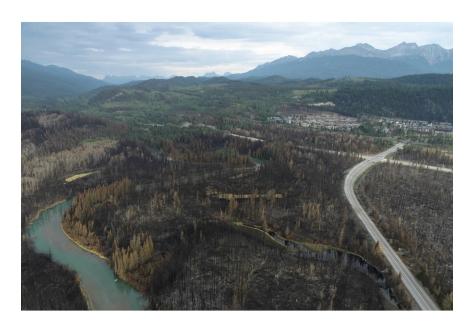
Figure 7: View looking northwest at the post-fire consumption of the wildland fuels leading up to the southwest side of Jasper townsite.

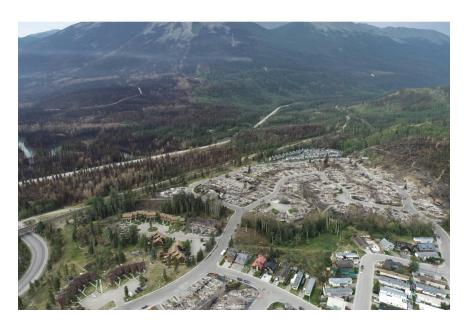
Figure 8: View looking southwest at the post-fire consumption of the wildland fuels approaching the southwest portion of the Jasper townsite.

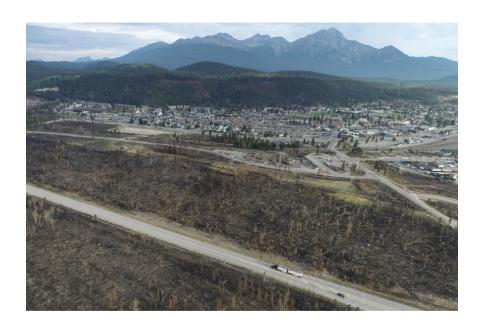
Figure 9: View looking north at the post-fire consumption of the wildland fuels leading up to the central portion of the Jasper townsite.

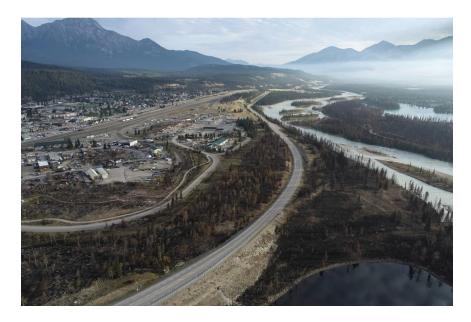
Figure 10: View looking northeast at the post-fire consumption of the wildland fuels surrounding the northeast portion of the Jasper townsite.

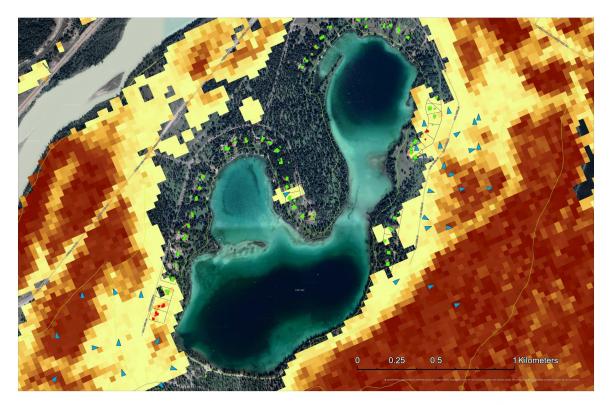
As the fire approached Lake Edith from the south it first encountered Lake Annette (Figure 20). The fire burned intensely up the east side of Lake Annette and based on the spread direction there it is possible that embers were lofted over the lake to start spot fires on the northern side. There was intermittent surface burning on the northern side of Lake Annette with spread in random directions indicating that there was not a strong pull or prevailing wind in the low intensity areas between Lake Annette and Lake Edith.

The area near the southwest corner of the lake was approximately 1 ha and experienced full canopy consumption only 100 m from the first structure on the southwest side of Lake Edith. Given the spread and wind direction, this area likely sent a significant ember shower towards the two structures that were burned. As the fire progressed up the east side of Lake Edith it encountered lower density fuels resulting in less canopy consumption and a lower intensity surface fire. The low-density fuels paired with the high intensity fire burning farther to the east seemed to have a pulling effect and most of the spread directions were away from the structures on the east side of the lake. However, there was a change in wind direction to the north, when paired with continuous fuels of sparse conifers mixed with long grass, allowed for fire to spread into the intermediate and immediate zones of the structures that were lost on the east side of the lake.

Figure 20: Lake Edith Cottage District. The degree of canopy consumption is shown with the coloured pixels while fire spread direction is shown with the blue arrows. The structures that are green have no easily visible fire damage, yellow have visible fire damage, and red are destroyed.

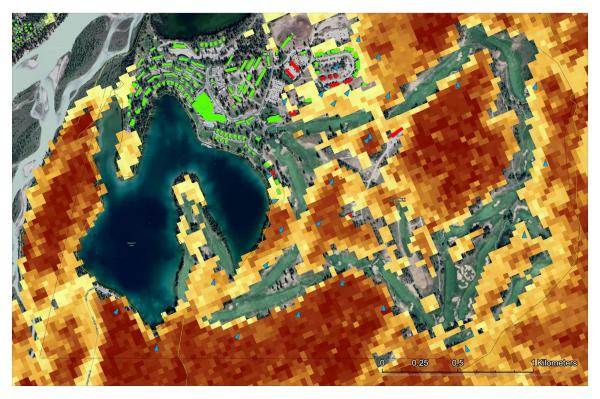
firefighters on the property during impingement. The conifer patches between the golf greens experienced full canopy consumption in most areas with some mixed wood areas at the transition zones experiencing lower canopy consumption (Figure 22).

Figure 22: Jasper Park Lodge. The degree of canopy consumption is shown with the coloured pixels while fire spread direction is shown with the blue arrows. The structures that are green have no easily visible fire damage, yellow have visible fire damage, and red are destroyed.

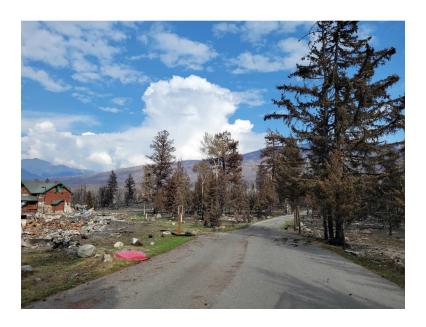
As the fire spread north of the golf course towards the structures in Thornton Village, on the northeast side of the property, the sparse canopy, pruning of lower branches, and minimal ladder fuel seemed to limit canopy consumption in this area. However, indicators of surface fire with average flame heights of 1-2 m and up to 4 m in some locations were still observed. Lower surface fire intensity was observed as the fire got closer to the southern structures in Thornton Village and jumped the road that leads to the golf course (Figure 23 and Figure 24).

Figure 23: Fire spread into the affected area of Thornton Village looking east.

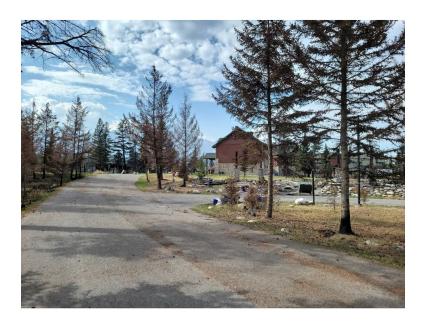
Figure 24: Fire spread into affected area of Thornton Village looking northwest.

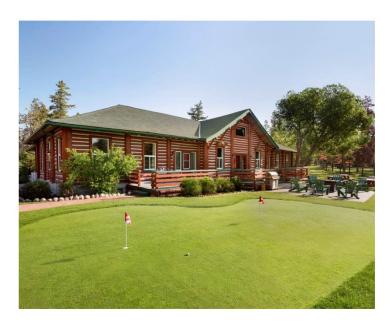
The Mulligan Cabin (Figure 26) was burned and possessed the following vulnerabilities that were absent on its unburned pair:

Figure 26: Pre-fire image from the Jasper Park Lodge website showing the now burned Mulligan Cabin.

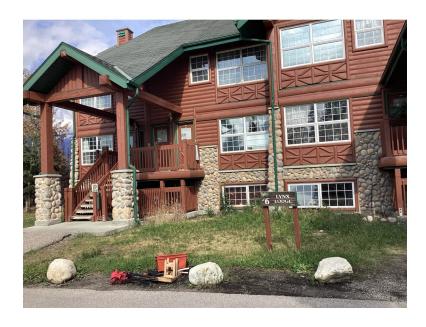
Figure 29: Thornton Village structure characteristics example.

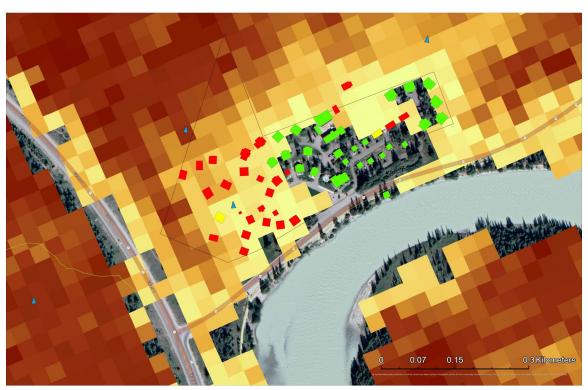
Ignitions occurred in the area due to wildfire embers that were lofted across the Athabasca River and the west side of Highway 93 (Figure 33). Tree and crown density on the southwest side of the property was more sparse than other areas to the north. However, the presence of significant ladder fuels throughout, feathermoss surface layer, and conifers with limbs to the forest floor allowed the fire to spread rapidly through the area with intermittent canopy consumption.

Figure 33: Alpine Village Resort Jasper. The degree of canopy consumption is shown with the coloured pixels while fire spread direction is shown with the blue arrows. The structures that are green have no easily visible fire damage, yellow have visible fire damage, and red are destroyed.

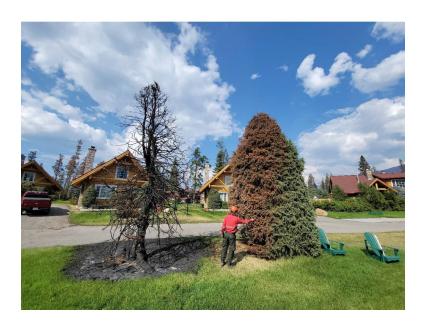
Spot fires developed randomly throughout the dense manicured spruce trees on the property (Figure 34), with unburned ones surviving right next to those that experienced full consumption. This effect was likely due to the prevailing winds and heat fluxes being pushed away from the surviving tree. This was also witnessed in several places in the wildland throughout the fire area (Figure 35). There were other spruce trees observed in isolation that had the bottom third fully consumed, the middle third charred, and the top third unaffected with angles of char pointing in the spread direction. The winds were likely strong enough that the top half of the tree was able to self extinguish as there was no evidence of firefighting activities in these areas.

Figure 34: Full consumption of a manicured spruce next to an unburned tree of similar characteristics.

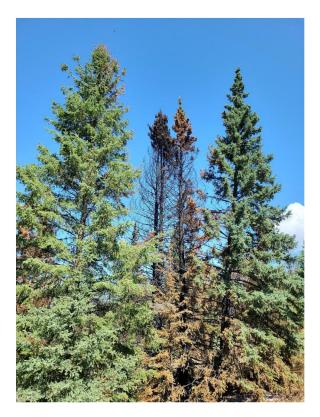
Figure 35: Example in the wildland showing consumption of trees between two unburned trees.

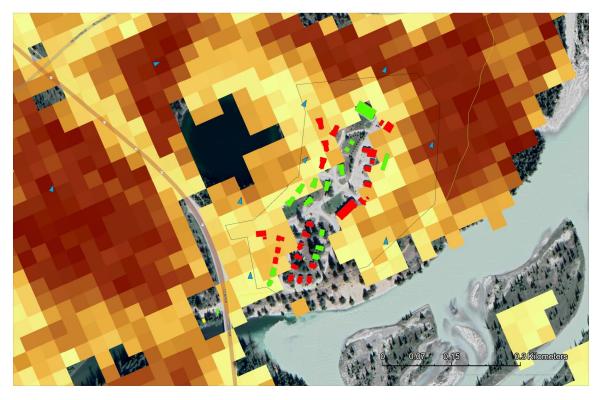
Figure 39: Tekarra Lodge. The degree of canopy consumption is shown with the coloured pixels while fire spread direction is shown with the blue arrows. The structures that are green have no easily visible fire damage, yellow have visible fire damage, and red are destroyed.

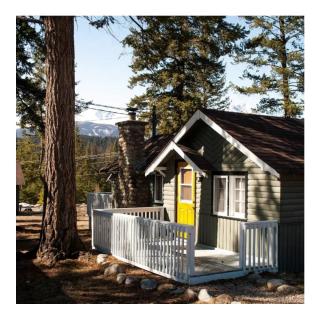
Figure 40: Image from Tekarra Lodge Facebook page showing pre-fire fuel conditions around the southwest side of the property.

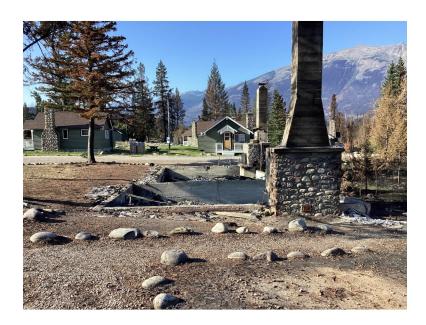
- Decks with wildland fuel and accumulation of litter around and under them on the west side of the structures,
- Continuity of burned wildland fuels up to the west side of the structures (Figure 41, Figure 42, and Figure 43),
- Combustible siding and features that extend to ground level, and
- Indicators that initial ignition and mass loss of the structure occurred on the western walls
  that were directly exposed to burning wildland fuels. Fridges within these structures fell
  towards the wildland fuels, suggesting that the western wall and floor gave way before
  other parts of the structure.

Figure 41: Looking south from the northwest side of Tekarra Lodge. The burned structures were built similarly to the two seen in the background.

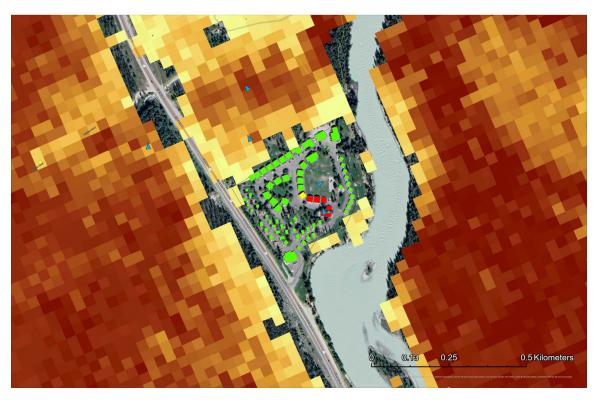
Figure 44: Beckers Chalets. The degree of canopy consumption is shown with the coloured pixels while fire spread direction is shown with the blue arrows. The structures that are green have no easily visible fire damage, yellow have visible fire damage, and red are destroyed.

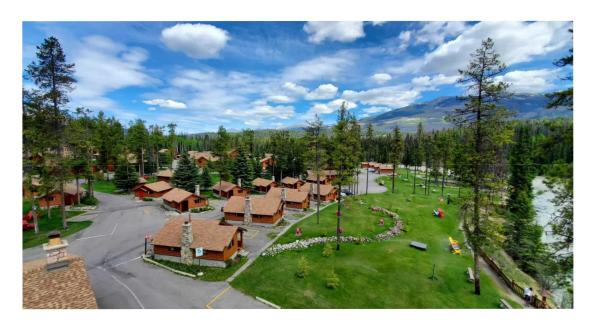
Many of the structures were constructed similarly with asphalt shingles, wood siding, and sufficient vertical clearance of the foundation above the surface (Figure 45). However, many of the structures had vulnerabilities such as densely pruned spruce shrubs up against their fronts with coarse bark mulch underneath them. Considering the spread direction indicators

Figure 45: Picture from Beckers Chalets Facebook page showing an elevated view of the property pre-fire.

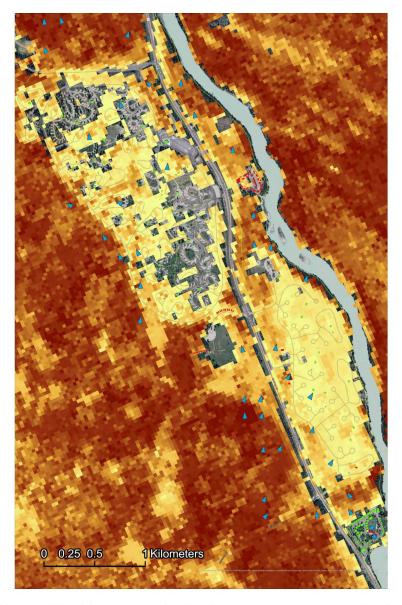
The fire spread directions surrounding Wapiti campground indicate that wildfire embers were likely lofted into the area from the south and west side of Highway 93. The intense fire burning on the opposite side of the Athabasca River could have pulled air towards it to give an easterly component to the winds. Numerous spot fires were distributed throughout the campground with some growing larger before they encountered roads or pathways. In addition, there were likely spot fires caused by fuels within the campground through torching and canopy consumption driven by the high winds. General progression through the campground was in the north-northeast direction (Figure 48).

Figure 48: Whistlers and Wapiti Campgrounds. The degree of canopy consumption is shown with the coloured pixels while fire spread direction is shown with the blue arrows. The structures that are green have no easily visible fire damage, yellow have visible fire damage, and red are destroyed. Dots for trailer locations follow the same colour convention as the structures.

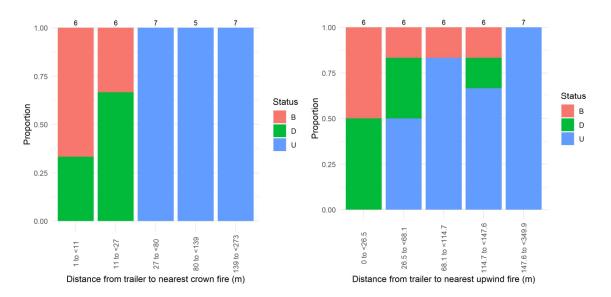
A Chi-Square test was used to test for differences in trailer destruction with distance from fire. Only the nearest crown fire (P < 0.001) and nearest 1 ha patch of fire (P = 0.0369) had statistically significant differences in the distance bins for exposure. The 1 to <11 and 11 to <27 m distance bins for the nearest crown fire were significantly different than all other bins (P < 0.05) but were not significantly different from each other. For the nearest upwind fire only the 0-26.5 m distance bin was significantly different from the 147.6-349.9 m distance bin (P = 0.0058) (Figure 51).

Figure 51: Trailer survival vs. distance to nearest crown fire and nearest upwind fire. B = burned. D = damaged. U = unburned. Numbers at the top of each bar represent the number of samples within that distance bin.

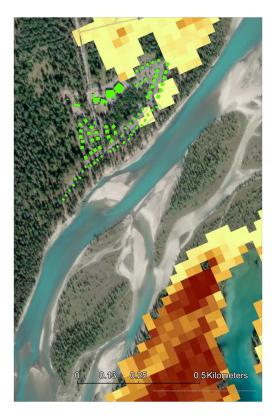
The head of the fire did not spread into the Pine Bungalows area and wildfire embers likely entered the area from the east side of the Athabasca River (Figure 55). Once the embers landed within the property there was minimal surface fire spread, with many isolated spot fires. There was not enough surface fuel to carry the fire and not enough ladder fuels to carry any of the low intensity surface fire up into the canopy (Figure 56). Spots fires were able to consume isolated juniper bushes and the surrounding vegetation mostly in the area between the river side cabins and the river. A few of the larger spot fires (Figure 57) were not able to progress close enough to the cabins through the very sparse fuels to cause any damage. There were many unburned mulch pathways between the cabins and the river. They seemed to resist burning due to the compaction from repeated walking on them and the small particle size that allowed for more compaction.

Figure 55: Pine Bungalows. The degree of canopy consumption is shown with the coloured pixels. The structures that are green have no easily visible fire damage.

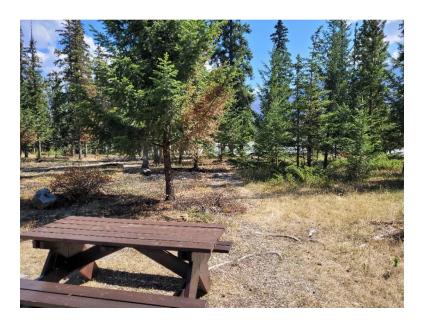
Figure 56: Spot fires between the Pine Bungalows and the Athabasca River.

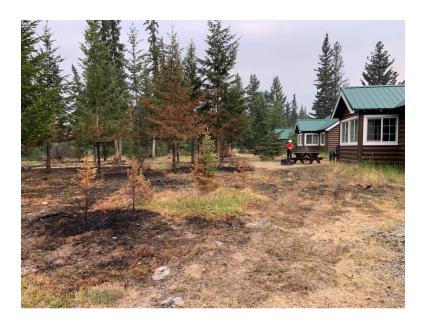
Figure 57: Spot fires near the Pine Bungalows along the Athabasca River

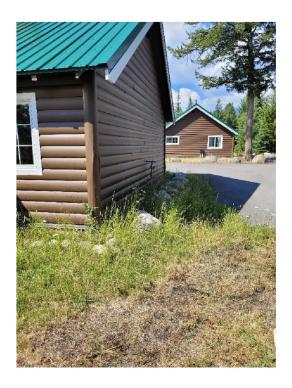
structure (Figure 58). Most of the plants were green and moist, potentially due to the absence of gutters on the structure, leading to increased moisture at the base of the structure for plant growth (Figure 59). Farther beyond this zone there was very sparse fuel that seemed to prevent spot fire progression up to the structures.

Figure 59: Typical fuel around the Pine Bungalows.
