ACTIVE ROCKSLIDES IN SWITZERLAND – UNDERSTANDING MECHANISMS AND PROCESSES

Erik Eberhardt, Engineering Geology, ETH Zurich, Switzerland
Heike Willenberg, Engineering Geology, ETH Zurich, Switzerland
Simon Loew, Engineering Geology, ETH Zurich, Switzerland
Hansruedi Maurer, Applied and Environmental Geophysics, ETH Zurich, Switzerland

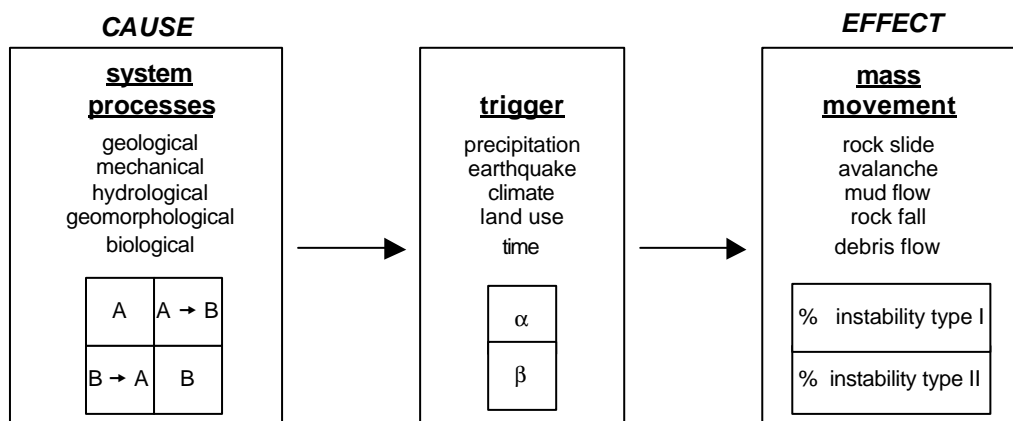
To answer the time question, in the framework of a conceptual model, requires the consideration of two factors that form the basis of most rock slope failure analyses. These are the initial slope conditions, or system processes, and the acting triggering mechanisms (Fig. 1). The initial slope conditions often involve, and in the case of most slope analysis methodologies require, the predefinition of the failure surface geometry as a continuous plane and/or as a series of interconnected planes (Fig. 2). It is unlikely, however, that such a network of natural joints forming a complete three-dimensional outline of the eventual failure surface exists prior to failure. The exception being in the case of excavated slopes where a daylighting set of discontinuities may be exposed during excavation allowing kinematic feasibility. In the case of natural rock slopes, consideration must be given to the fact that the slope has remained relatively stable over the past several thousand years with few major external changes occurring with respect to its kinematic state (e.g. loss of confinement along valley walls during glacial retreat). This is not to say that a

Figure 1. Illustration of cause, involving the interrelationship between system processes and triggering mechanisms, and their effect on inducing mass movements.

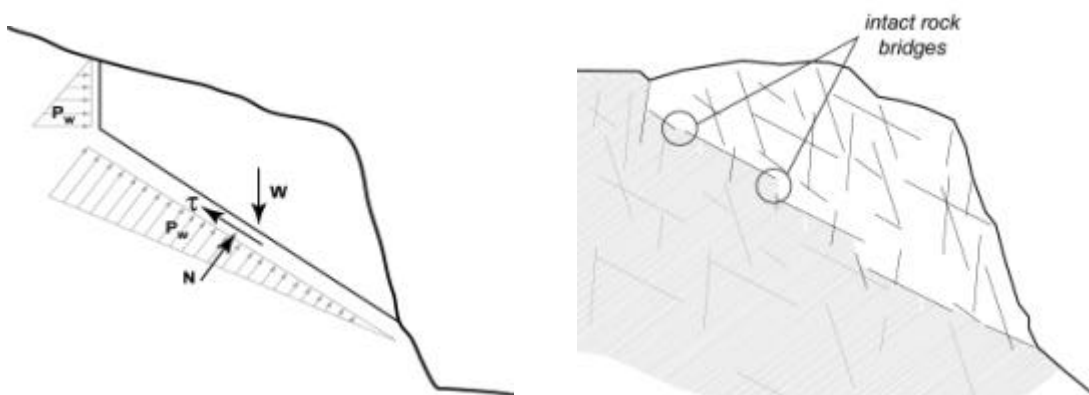
system of natural discontinuities may not be interconnected forming a significant portion of what will eventually be the failure plane, but that a component of strength degradation with time must occur within the system. For example, the system may incorporate time-based elements such as material creep, fracture propagation, stress corrosion and/or weathering, which in turn act to reduce with time the strength of asperities between locked joint surfaces and/or intact rock bridges situated between natural discontinuities (Fig. 2).

Figure 2. Continuous sliding surface assumed in simplified rock slope stability analysis (LEFT); rock slope with discrete natural discontinuities and intact rock bridges (RIGHT).

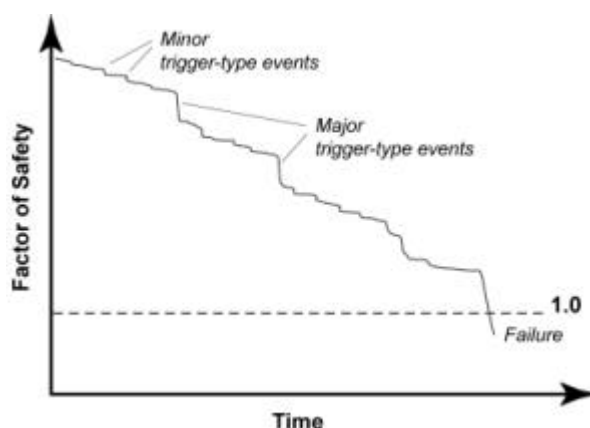
Conceptually then, rock slope failure can be viewed as the progressive accumulation of events with time that act to degrade the equilibrium state of the slope, with each event bringing the slope nearer to failure (Fig. 5). In other words, each triggering type episode, such as a heavy rainfall or freeze-thaw cycle, can be viewed as progressively reducing the effective strength or cohesion of the rock mass (e.g. intact rock bridges) until the last triggering episode provides the proverbial “straw that broke the camel’s back” and failure occurs. Thus it is the time factor that contributes to the development of the sliding surface in natural slopes by means of progressive failure.

Figure 5. Conceptual illustration showing decrease in factor of safety as a function of time, i.e. progressive failure, due to repeated occurrences of triggering-type mechanisms.
